September 2001 Newsletter

The X-43A Flight Failure By Tom Irvine

THE TACOMA NARROWS BRIDGE FAILURE By Tom Irvine

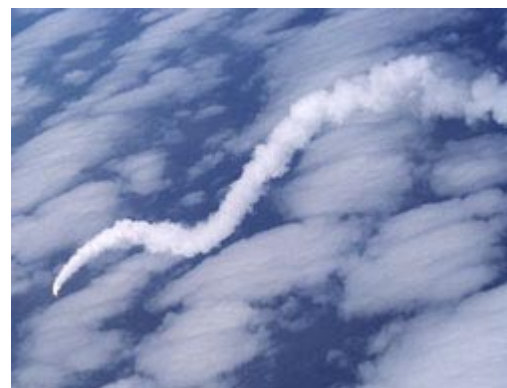
Figure 3. The X-43A/Pegasus Vehicle Gyrates out of Control

Unfortunately, the X-43A mission was lost after moments after the X-43A and its booster rocket were released from the wing of the B-52 carrier aircraft. Following booster ignition, the combined booster and X-43A experienced structural failure and deviated from its flight path. Video footage showed that the Pegasus starboard fin detached during the failure. Whether the fin broke as a cause or effect of the failure was not immediately clear. Note that the fins are moveable fins that are used to steer the vehicle.

As of late August, the focus of the ongoing failure investigation is the fin control algorithm. The aerodynamic forces encountered in flight were more severe than the preflight predictions. The control gain factors were thus set for a less severe environment. As a result, the fins attempted to over-steer vehicle. The aerodynamic

forces then caused a loss of control and a structural failure.

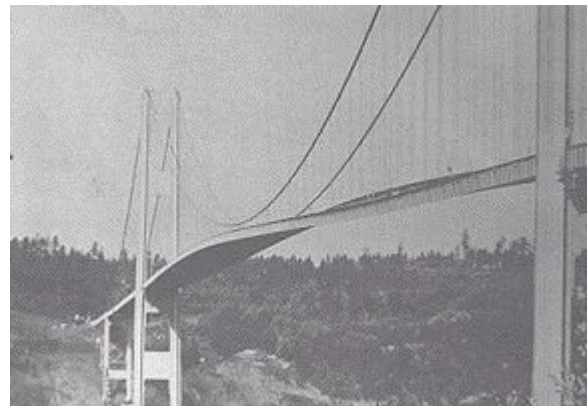
The wind then increased to 42 miles per hour. In addition, a support cable at mid-span snapped, resulting in an unbalanced loading condition. The bridge response thus changed to a 0.2 Hz torsional vibration mode, with an amplitude up to 28 feet. The torsional mode is shown in Figure 1.

Figure 1. Torsional Mode of the Tacoma Narrows Bridge

The torsional mode shape was such that the bridge was effectively divided into two halves. The two halves vibrated out-of-phase with one another. In other words, one half rotated clockwise, while the other rotated counter-clockwise. The two half spans then alternate polarities.

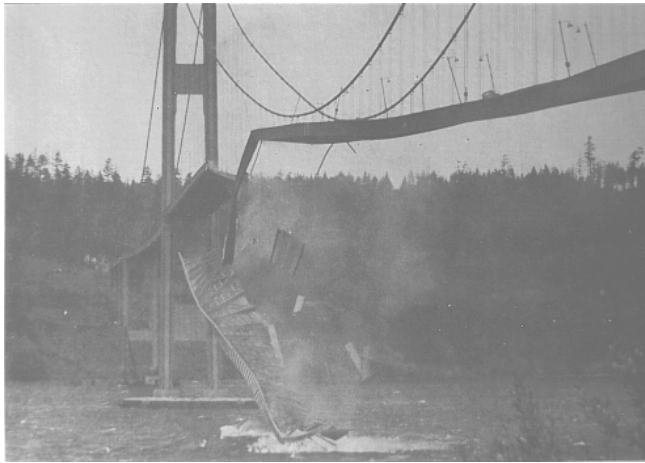
The bridge collapsed during the excitation of this torsional mode. Specifically, a 600-foot length of the center span broke loose from the suspenders and fell a distance of 190 feet into the cold waters below. The failure is shown in Figures 2a and 2b.

Figure 2a. Failure of the Tacoma Narrows Bridge

The fundamental weakness of the Tacoma Narrows Bridge was its extreme flexibility, both vertically and in torsion. This weakness was due to the shallowness of the stiffening girders and the narrowness of the roadway, relative to its span length.

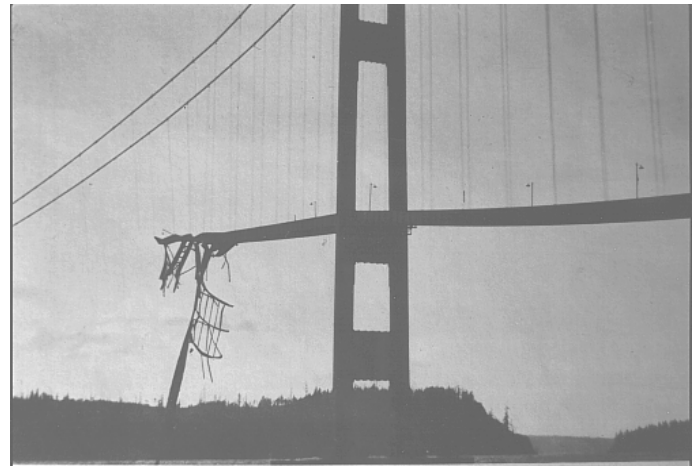
Figure 2b. Tacoma Narrows Bridge after the Failure

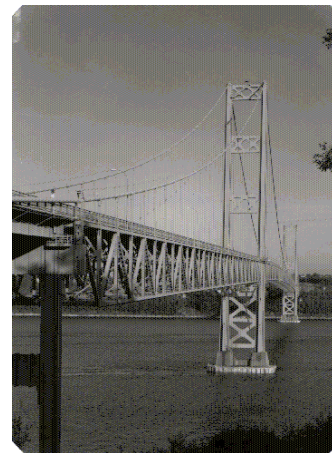
Figure 5. The Replacement Tacoma Narrows Bridge, Built in 1950

A new Tacoma Narrows Bridge was built in 1950, as shown in Figure 5. The second bridge had truss-girders which allowed the winds to pass through. It also had increased torsional stiffness because it was thicker and wider. Furthermore, wind tunnel testing was performed to verify the design of the new bridge prior to its construction.
