Battery Box Shock Failure Case History

Introduction

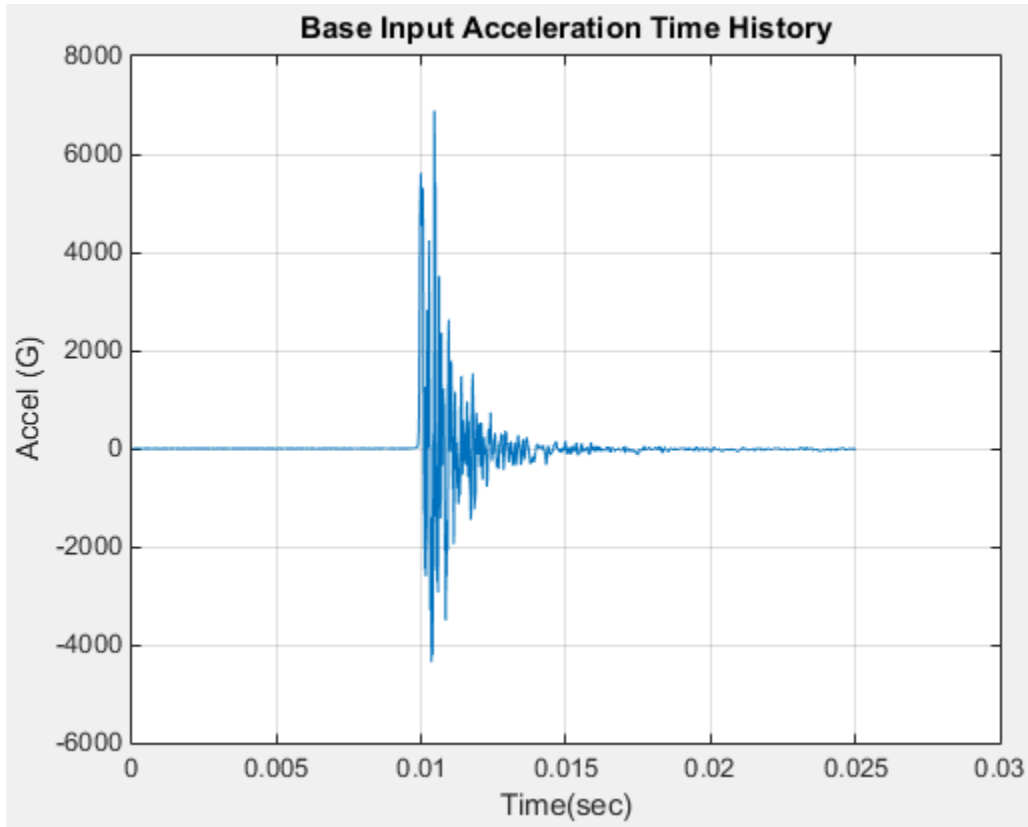
Figure 1.

A colleague wrote me that a certain launch vehicle battery box failed its shock test which was performed on a drop table. The purpose was to simulate a stage separation pyrotechnic event. The failure mode was cracking in a plexi-glass type material encasing silver zinc battery cells.

Additional information regarding the box was not disclosed due to sensitive reasons. But I was given the acceleration time history as shown in Figure 1 for review.

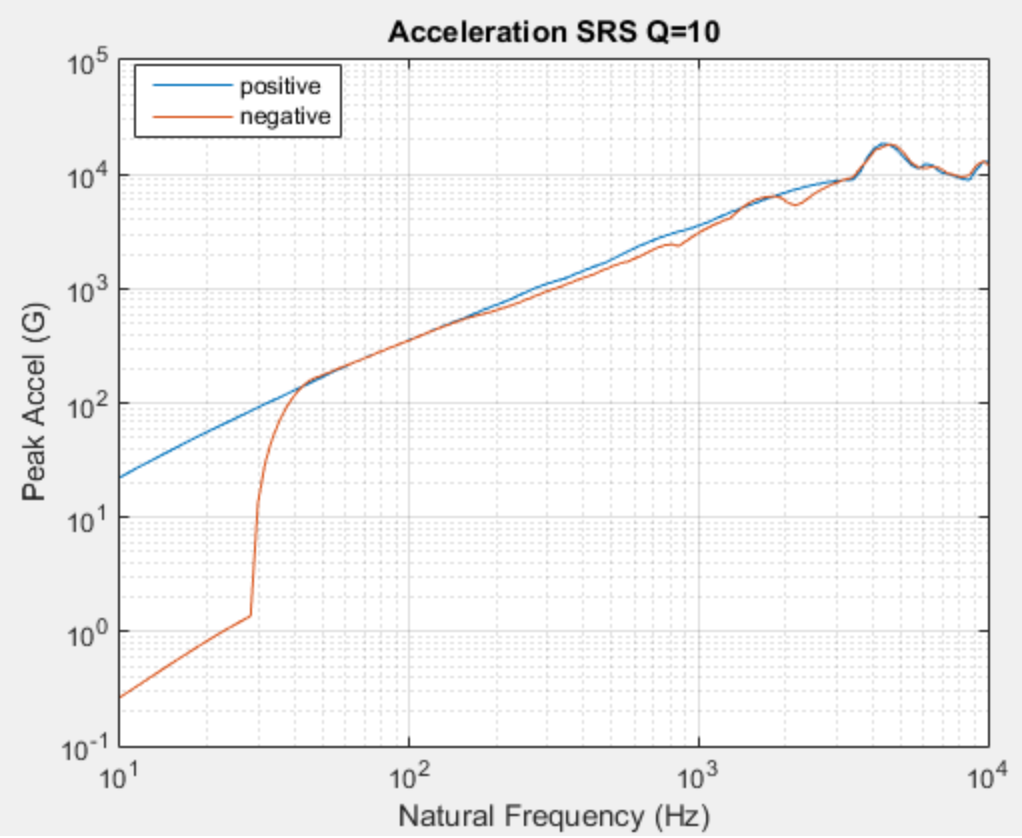
Figure 2.

The acceleration and pseudo velocity SRS plots are given in Figures 2 and 3, respectively.

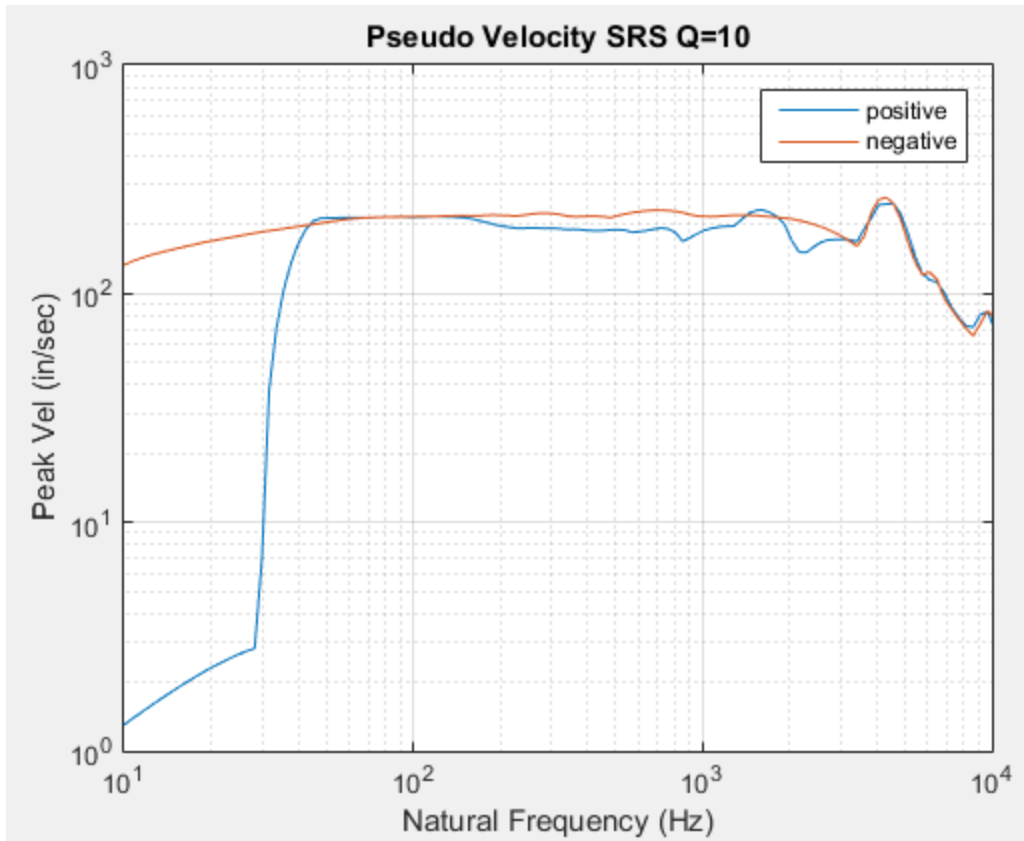
Figure 3.

The pseudo velocity level is approximately 200 in/sec over most of the frequency domain. So this level appears to be somewhere above the severity threshold for at least some types of battery boxes.

The normal severity threshold for equipment is 100 in/sec, which some references applying a 6 dB margin to reduce the level to 50 in/sec.
