This paper was presented at JSPS Seminar on Engineering in Japan at the Royal Society, London, on September 27, 1999. The seminar was organized by the Japan Society for the Promotion of Science.

Disaster Mitigation Engineering - The Kobe Earthquake Disaster -

SHUNSUKE OTANI,
Professor, Department of Architecture, University of Tokyo

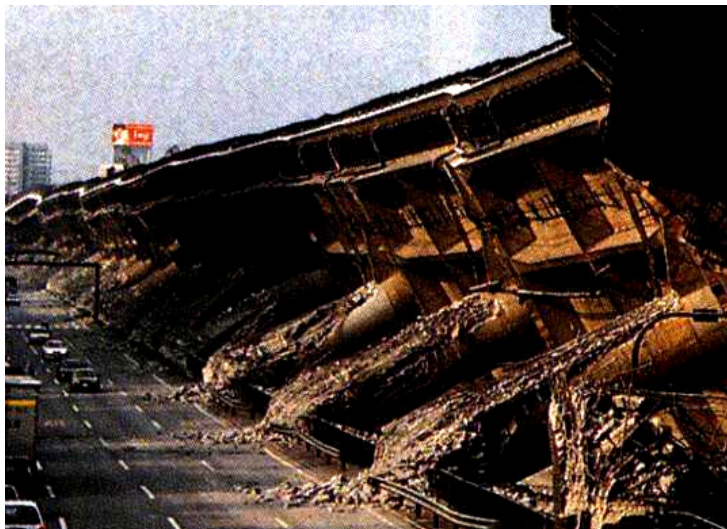
Typical examples are the collapse of highways (Fig. 1) or the collapse of Shinkansen line (Fig. 2). The city of Kobe was developed in the east-west direction along the seashore with steep hills behind. Therefore, all major traffic networks like highways and railways run in the east-west direction. Once the networks were cut by major damages at a few limited points, the entire system stopped functioning. Without highways and railways, the transportation of relief goods was delayed by traffic jams on major ground routes despite the efforts to control traffic by police and local government.

Fig. 1: Collapse of highway overpass

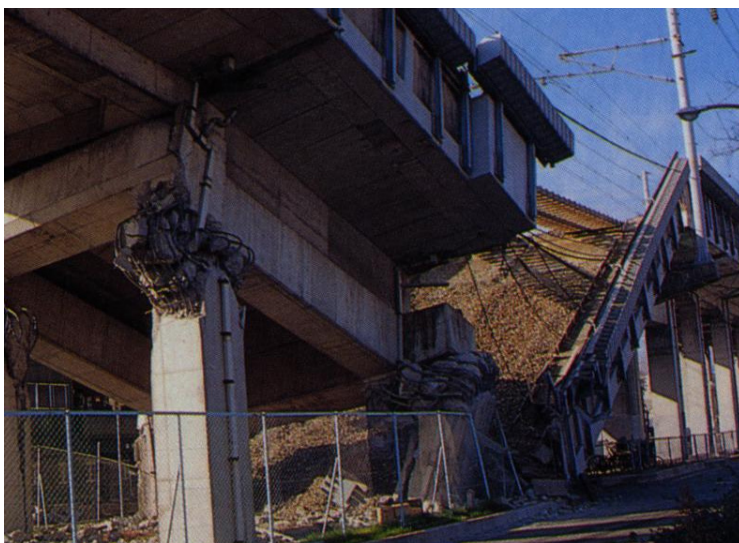
Fig. 2: Collapse of the Shinkansen overpass

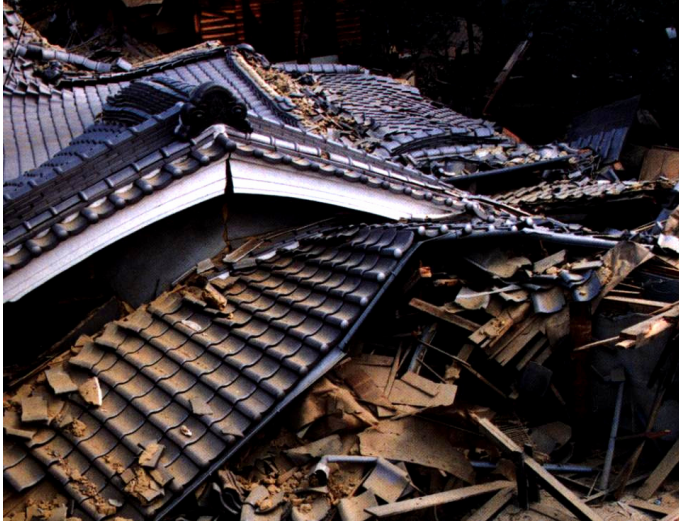
Major death occurred under the collapse of traditional timber houses. This is related to their construction; i.e., heavy mud and tiles are used in the roof in these timber houses (Fig. 3). The heavy roof attracted large inertia forces during earthquake shaking and caused the collapse. We need to study this point further. The weather in Japan is quite warm and humid in summer. In order to insulate heat we have to use heavy materials in the roof; this is necessary to gain comfort during the summertime. At the same time, in every autumn, we have one or two typhoons. In order to protect roof against blow-up, we have to make roofs heavier. By these reasons of the amenity in daily life and safety against annual events, we made roofs very heavy in old traditional timber houses. However, the heavy roofs caused ill effects on earthquake resistance. Note that the last earthquake that hit in this area was in the 1590's, more than four hundred years ago.

Fig. 3: Collapse of old timber house with heavy roof

At the same time the collapsed houses were generally very old. Structure decayed with age, and sometimes the column was even eaten up by termites. The structure did not give us redundant strength to resist an earthquake motion.

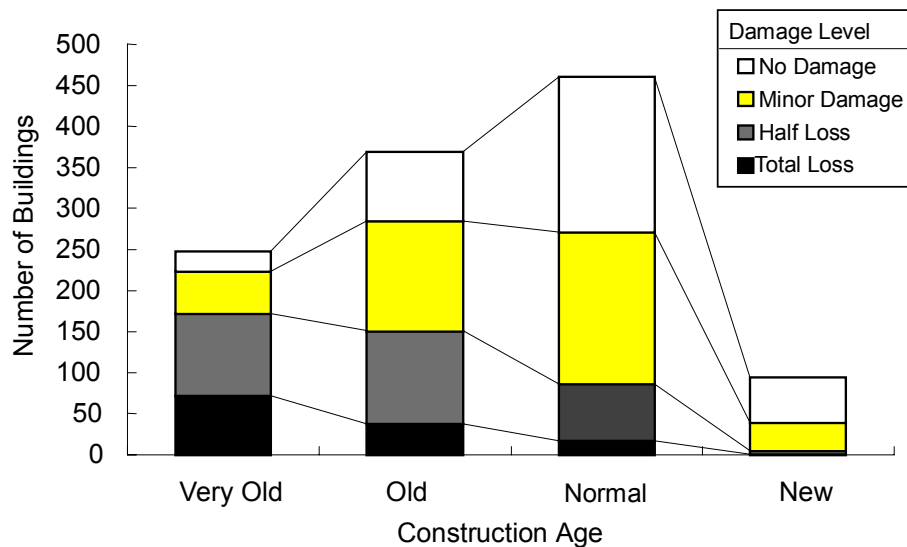
Figure 4 shows damage statistics of timber houses at different construction ages (Ref. 1). The data were reported for houses in Awaji Island near the epicenter. The construction age may be classified as new if constructed within 5 years, normal within 5 to 20 years, old within 20 to 50 years, and very old more than 50 years. Note that heavy damage increases with old construction age. More than half of those constructed within 5 years suffered no damage while most of those constructed more than fifty years ago suffered damage ranging from collapse to minor damage. The figure indicates a significant improvement in technology for earthquake resistant construction of timber houses in recent years, and also implies the importance of maintenance work on houses.

Fig. 4: Damage statistics of timber houses

If people could spend more money to improve the structures of their houses partially by maintenance work on decayed materials and partially by strengthening old construction, the damage and accompanying casualties could have been reduced. The improvement in engineering is not meaningful unless the new technology is adopted in real construction by citizens.

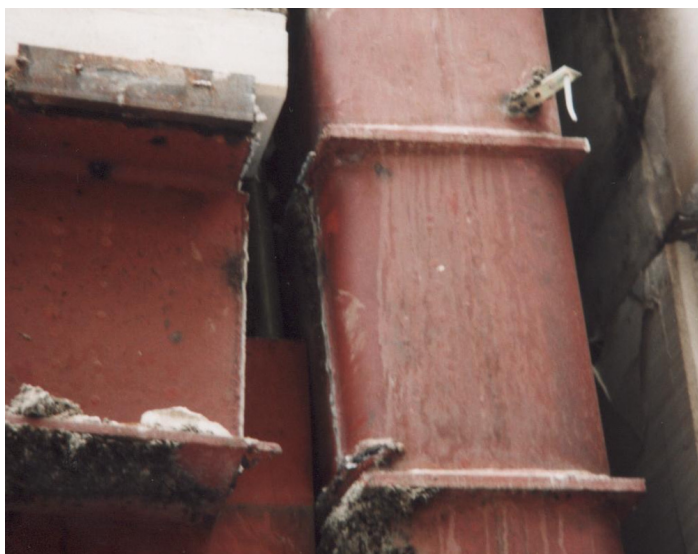
Fig. 5: Failure of steel structure at welding connection

Even in the welding connection using the state of practice, the failure was observed in the steel

element after developing yielding near the welding. Similar failure was observed in steel construction in California after the 1994 Northridge earthquake. Researchers of steel structures are extensively studying this problem in U.S. and Japan.

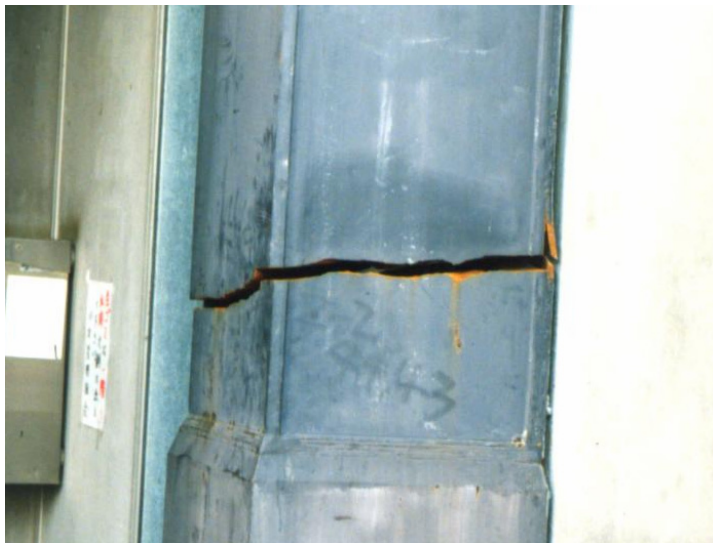
We found another major problem in steel construction; brittle fracture of large size steel members as shown in Fig. 6. Crack width is almost 15 mm. This damage was observed in some high-rise apartment buildings in a large residential development. Steel plates of approximately 50 mm thick were welded to form large square column section. Before the construction, steel members were tested in the laboratory under simulated earthquake loading to confirm the safety, but using “small scale” specimens. It appears that the behavior of thick steel members is significantly affected by their size. Although I doubt the capability of carrying out full-scale testing of the column in the laboratory, we should be careful when we develop new technology.

Fig. 6: Brittle fracture of large-size steel members

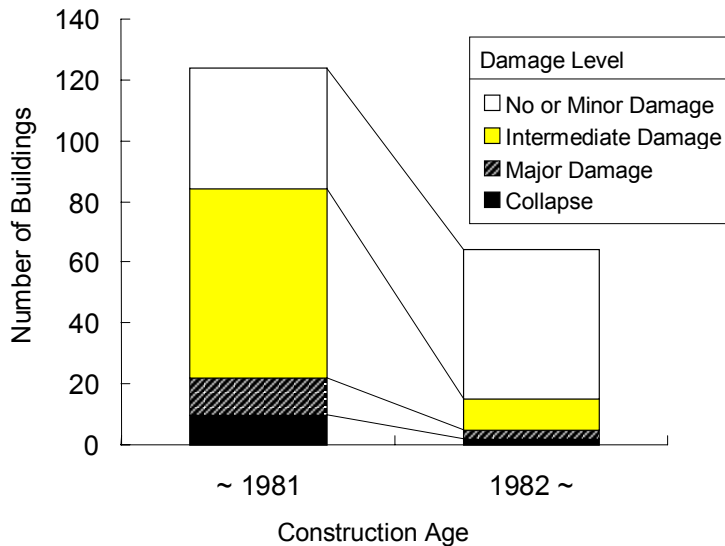
Figure 7 shows the damage statistics of steel buildings with respect to construction age. The Building Standard Law was significantly revised in 1981 to require the examination of horizontal load resisting capacity at the formation of the yielding mechanism under lateral forces. The minimum lateral load resistance was specified in accordance with the deformation capacity of members forming yield hinges. It should be noted that the rate of severe damage decreased appreciably for those constructed after the 1981 revision of the law. We believe that the current state of the art is sufficient for the earthquake resistant building construction. However, some of those buildings constructed before the revision of the law should be examined as to the earthquake safety and must be strengthened if significant deficiency is found.

Fig. 7: Damage statistics for steel buildings with construction age

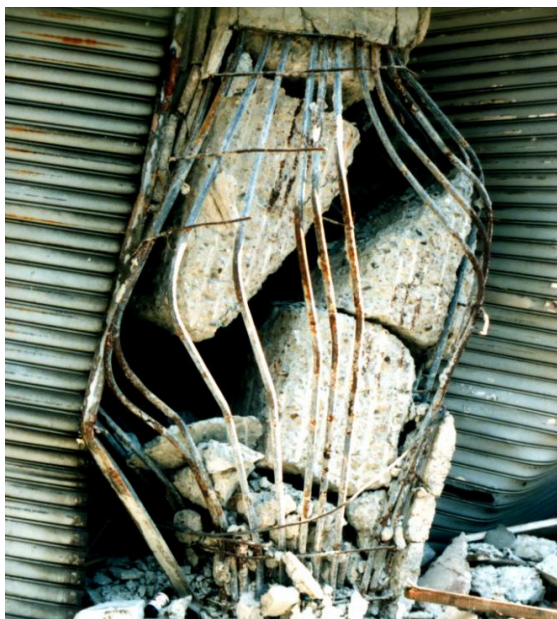
Many reinforced concrete buildings collapsed by the earthquake. The column supporting the weight of the structure above failed in a brittle manner, the failure mode of which is commonly known as “shear failure.” The same failure mode was observed in the 1968 Tokachi-oki earthquake in school buildings. The characteristic of this failure mode is that the width of the column becomes much larger after failure than the original width as shown in Fig. 8. Therefore, the failure can be prevented by reinforcing the column laterally.

Fig. 8: Shear failure of reinforced concrete column

The Building Standard Law was revised in 1971 to require close spacing of lateral reinforcement in columns. The performance of reinforced concrete building constructed after the 1971 revision of the law was generally improved. The Building Standard Law was further revised in 1981 to require higher lateral resistance from a building irregular in the distribution of stiffness in plan or along height in addition to the examination of lateral load resistance at the formation of the yielding mechanism under earthquake loading.

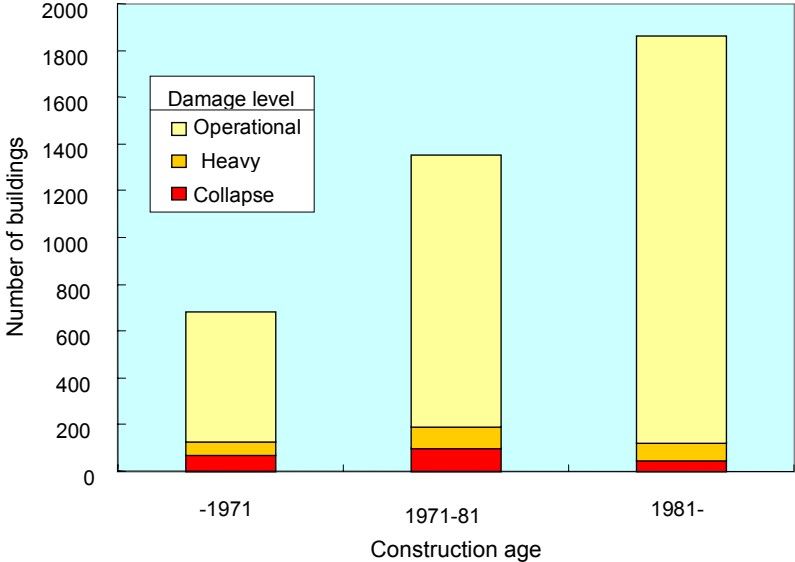
The Architectural Institute of Japan investigated the damage level of all buildings in Nada and Higashi-Nada districts in Kobe where the seismic intensity was highest; 3,911 buildings in total were investigated (Ref. 2). Seventy-five percent were residential buildings (including those used partially for office or shop). Forty-eight percent were built in conformance with the current Building Standard Law (revised in 1981). The damage level was classified as operational damage (no damage, light damage and minor damage), heavy damage (intermediate damage and major damage), and collapse (including those already removed at the time of investigation). Buildings with operational damage could be occupied immediately after the earthquake. Buildings with heavy damage needed some or major repair work for the occupancy.

Fig. 9: Damage of reinforced concrete buildings with construction age

Eighty-nine percent suffered operational damage, 5.9 percent suffered heavy damage and 5.7 percent collapsed. Among those 2,035 buildings constructed before the current Building Standard Law (1981), 7.4 percent suffered heavy damage and 8.3 percent collapsed. Among those 1,859 buildings constructed using the current Building Standard Law, 3.9 percent suffered heavy damage and 2.6 percent collapsed. The 1981 revision of the Building Standard Law enhanced significantly the performance of reinforced concrete buildings against earthquake attack.

We may say that the reinforced concrete building designed using the state of the art and practice is reasonably safe against earthquakes. Approximately 15 percent, or possibly 20 percent, of those buildings constructed before the current Building Standard Law (revised in 1981) need strengthening in Japan for the preparation against future earthquake events.

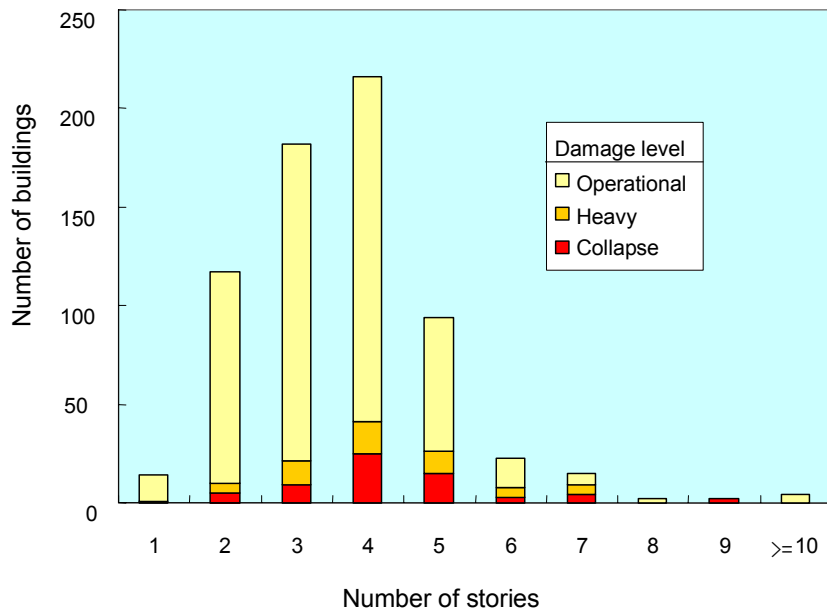
Figure 10 compares the damage of those buildings constructed before the 1971 revision of the Building Standard Law with respect to the height (number of stories). The damage levels are operational damage, heavy damage and collapse. You can observe that the ratio of buildings suffering operational damage is much larger for low-rise buildings. The ratio of buildings suffering heavy damage and collapse increases in medium-rise buildings (say, taller than five-stories). A structural designer should pay more attention to earthquake resistant design when he/she designs taller buildings.

Fig. 10: Damage of pre-1971 reinforced concrete buildings with story height

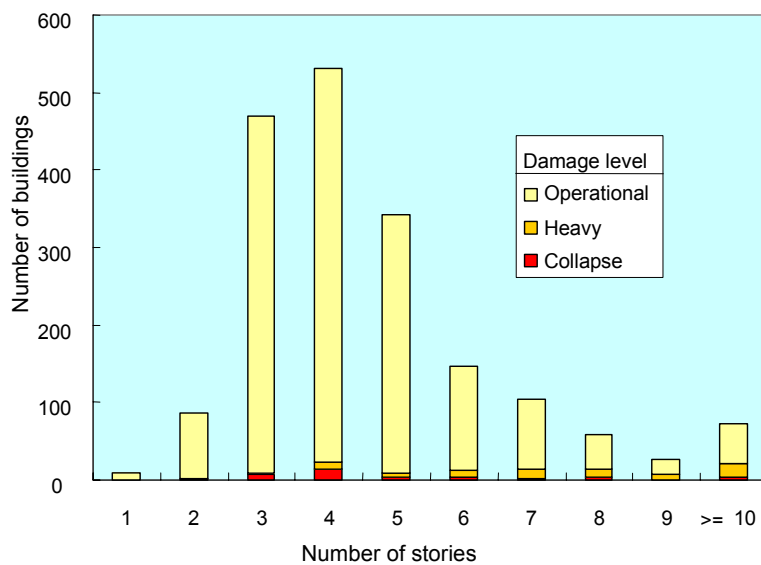
Figure 11 shows a similar diagram for those constructed after the 1981 revision of the Building Standard Law. A significant improvement may be observed in the protection of buildings using current Building Standard Law. However, the ratio of severe damage is higher in taller buildings.

Fig. 11: Damage of post-1981 reinforced concrete buildings with story height

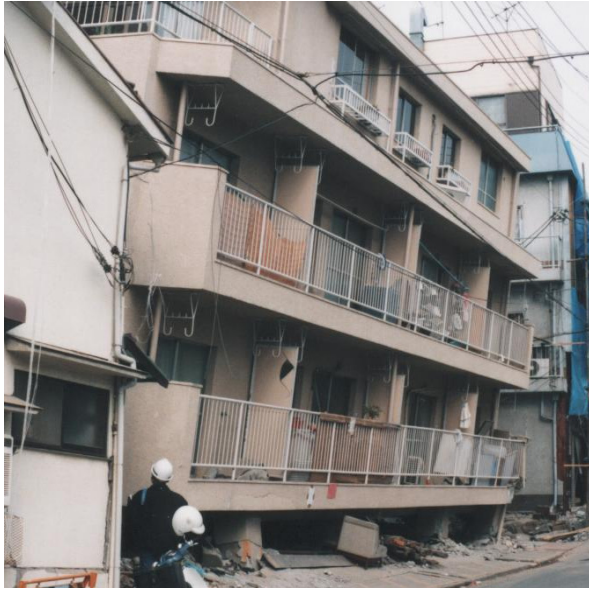
One characteristic failure of reinforced concrete buildings in Kobe was the collapse in the first story as shown in Fig. 12. This type of failure was observed in many apartment and condominium buildings. Residential units are separated by partition walls, normally by reinforced concrete structural walls, which effectively resist earthquake forces without much deformation. The ground floor is normally used for garage or stores in Japanese residential buildings due to the limitation in area. Therefore, no partition walls were placed in the ground floor. In other words, the upper stories are generally strong with ample structural walls whereas the ground floor is bare against earthquake attack. This type of the structure is called “soft first-story buildings.” By this reason, the collapse took place in the ground floor in the form of shear failure of columns.

Fig. 12: Collapse of reinforced concrete buildings in first story

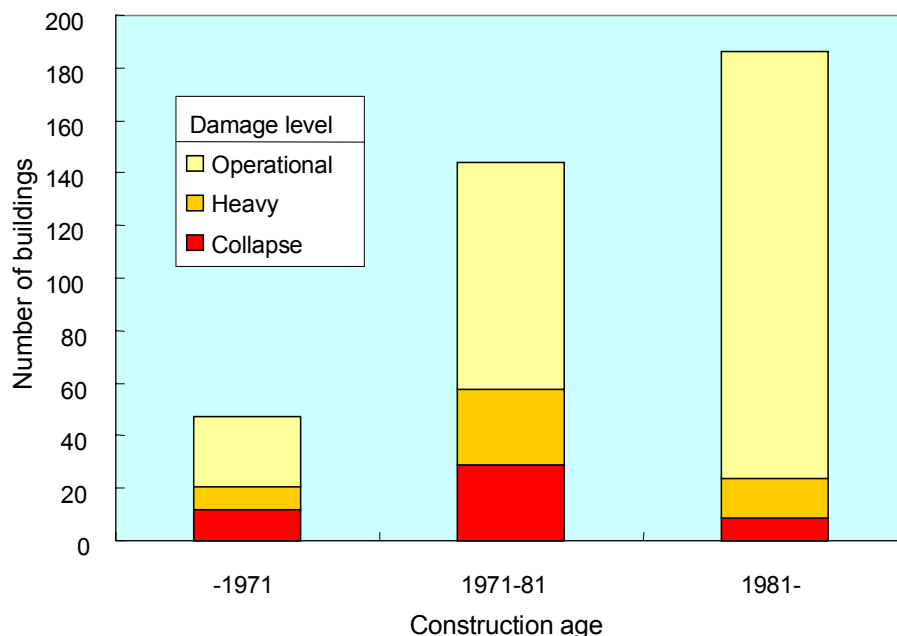
Figure 13 compares the damage of soft first-story buildings with construction age; i.e., before the 1971 revision of Building Standard Law, between 1971 and 1981, and after the 1981 revision of the law. You can note a significant improvement in the safety of the soft first-story buildings with the revisions of the Building Standard Law. Almost one half of those soft first-story buildings constructed before the 1971 revision suffered severe damage or collapse. We are not satisfied with the performance of soft first-story buildings constructed in accordance with the current Building Standard Law. We need the improvement in design of these buildings.

Fig. 13: Damage of soft first-story buildings with construction age

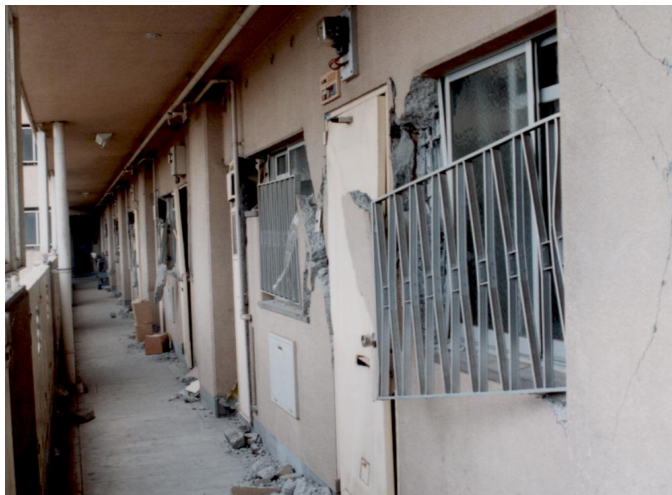
Let us look at the damage of an apartment building in Fig. 14. You can observe extensive damage in reinforced concrete partitions and windows. No one would want to live in the unit after seeing such damage. However, if we examine the damage carefully, there is almost no damage in structural elements such as columns and girders. I looked at this building as a structural engineer, and concluded the structural damage was minor. Damage was observed only in non-structural elements such as partitions, doors and windows. These non-structural elements were not intended to support the weight of the building, but are necessary for the use of the building as residential units.

For example, the breakage of non-structural partitions in Fig. 14 will not allow people to live in the residential unit. The partition is not a structural element, but the partition was broken, people cannot use the unit at all. In the past, structural engineering placed too much emphasis on the safety of people, but now I think it becomes more important to protect functions of a building.

Fig. 14: Damage of non-structural elements
