PYROTECHNIC SHOCK FLIGHT FAILURES*
By: C. J. Moening, The Aerospace Corporation

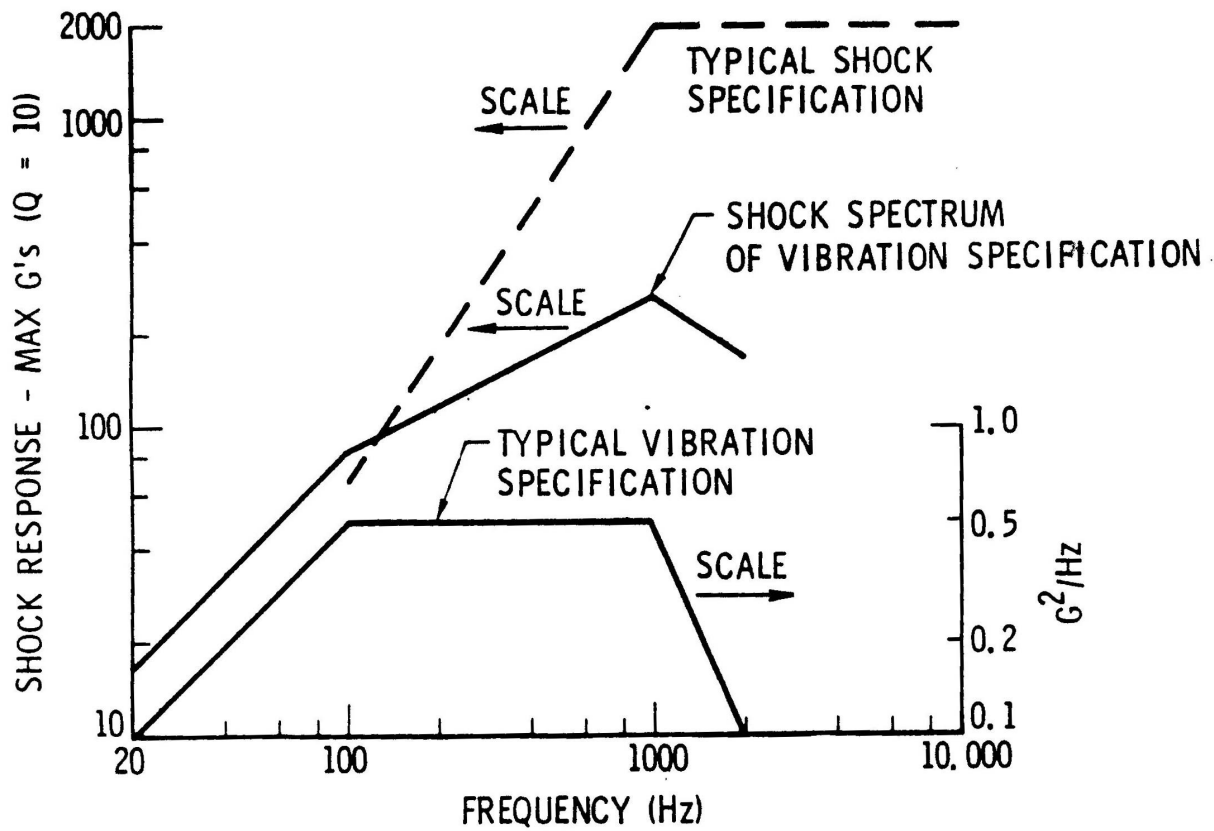
Fig. 1. Pyrotechnic Shock versus Vibration Levels

vibration test of several minutes duration would surface failure modes that could occur as a result of a typical 10 to 20 msec duration pyrotechnic shock environment. The error in this assumption is shown in Fig. 1 where a comparison is made of typical shock and vibration specifications for space vehicle equipment. In Fig. 1 the vibration specification has been translated to a response spectrum for comparison with the shock specification. This comparison shows that at all frequencies above approximately 150 Hz, the peak shock accelerations are much higher than the vibration accelerations. Failure mechanisms caused by peak shock acceleration therefore would not be detected by the lower amplitude vibration.
