Recognition and Correction of Sonic Fatigue Damage in Fighter Aircraft

Mr. Salvatore L. Liguore, Dr. Theodor H. Beier

The Boeing Company, PO Box 516
St. Louis, MO 63166-0516, USA

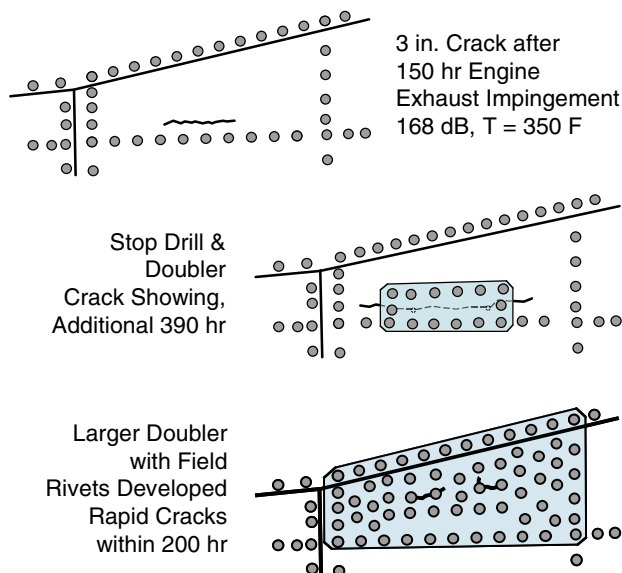
(2) A small fuselage skin panel, Figure 2, incident to the engine exhaust plume exhibited cracks after 150 hr. The cracks were stop drilled and small riveted doublers were applied. Within another 200 hr the cracks were appearing from beneath the doublers. Other aircraft were repaired with larger riveted doublers containing a myriad of “field rivets.” In a short time cracks began to occur in the doublers at the rivets. This example typifies the inability of mechanically fastened doublers to arrest sonic fatigue cracking.

Figure 2. Failed Traditional Sonic Fatigue Repairs

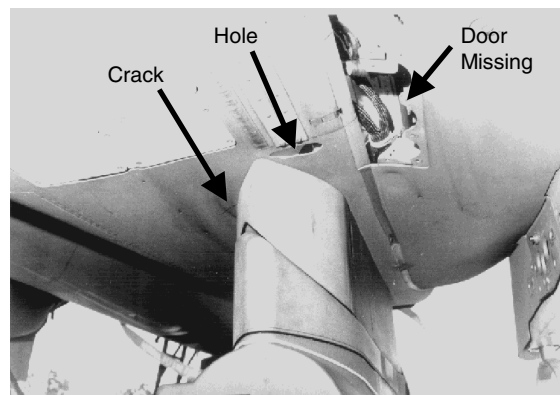
(3) After installation of a blunt ended pod beneath the fuselage, aircraft began suffering skin cracking and door damage after high Q sorties. After one particularly demanding occurrence, an aircraft returned with the damage shown in Figure 3. This is an example of the damage that can be caused by turbulent wakes and shocks.

Figure 3. Sonic Damage After Prolonged High Q Flight

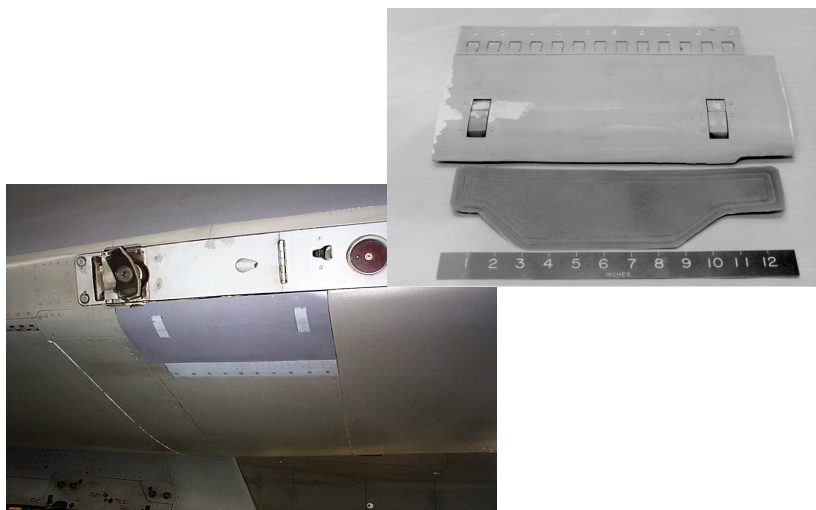
On June 17, 1998, an F-15 flew for the first time with a damped composite bonded patch installed on the center fuselage chine door. The patch is a demonstration of pre-emptive type repair technology suitable for sonic fatigue prone structures. This door, and other similar ones, have had a history of damage including skin cracks, latch wear, and hinge fitting cracks. Figure 7 shows the door and patch prior to bonding and as installed on the aircraft. The patch consists of Textron Boron/Epoxy 5505 with a 3M adhesive integrated into the laminate. The patch was then bonded with paste adhesive onto the surface prepped door and cured in an autoclave for a full bonding. This door has been operational on a Boeing/USAF flight test aircraft for over two years.

Figure 7. Center Fuselage Chine Door w/ Damped Patch

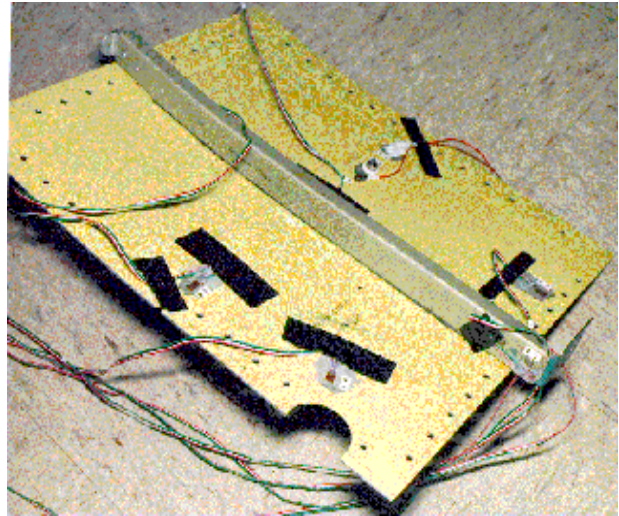
The second demonstration is a lower surface skin panel on the F-15, Figure 8. This panel is part of the lower nacelle skin assembly and experiences high dynamic response during low altitude and high-speed maneuvers. The panel is made of 2024 Al. It is 0.071 inches thick with chem-milled pockets to 0.060 inches and 0.044 inches, and has experienced cracks in the former and in the panel chem-mill boundary. According to Figure 5, this panel is a good example of how a doubler could aggravate the problem if not properly designed to lower loads at the panel edge.

Figure 8. Lower Nacelle Skin Panel Removed from Aircraft Showing the 487.3 Former

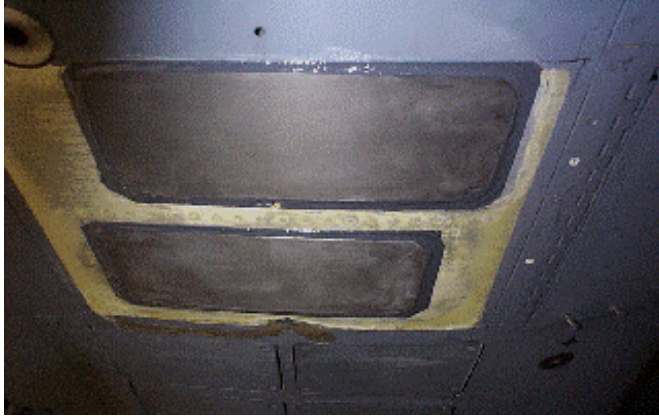
Figure 10. Patches Installed on A/C Prior to Painting -- Looking Aft

A composite patch system was designed with integral damping treatment, as a simple and low cost retrofit, two 10 by 5-inch rectangular patches of boron/epoxy with integral damping. The complete laminate contains Textron Rigidite Boron 5505, and a damping pack comprised of damping and constraining layers (patent pending). The final patches are shown as installed on the aircraft, Figure 10.
