September 2011 Newsletter

Wake Turbulence by Tom Irvine

Atmospheric Turbulence By Tom Irvine

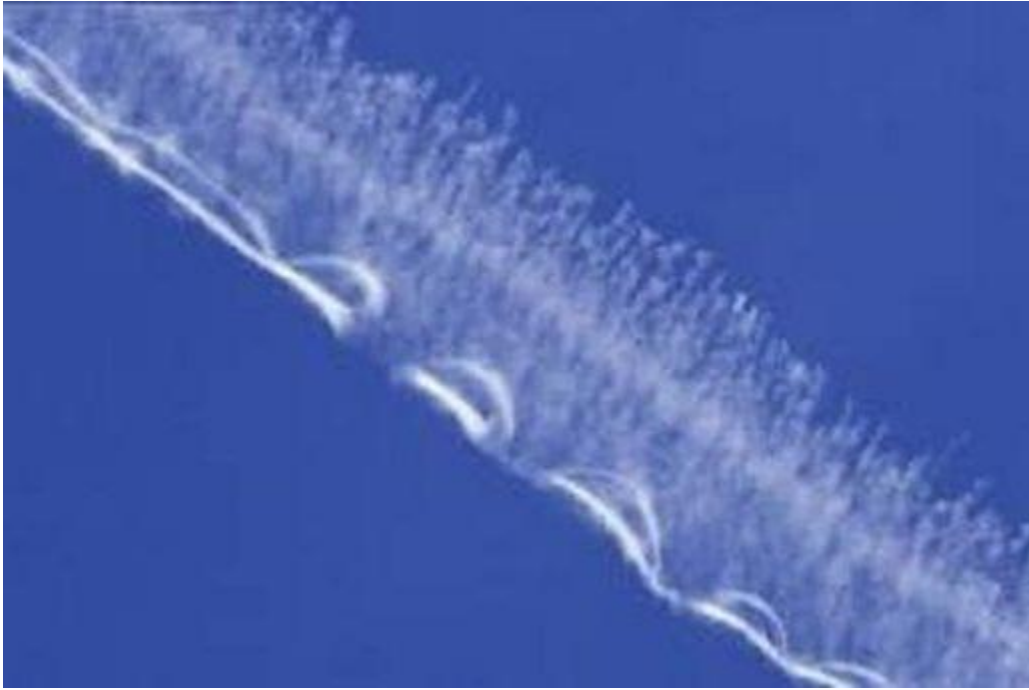
Figure 4. Crow Instability

Note that the vortices only spread apart when they are in “ground effect.” Otherwise they move together as shown in Figure 4, until they become unstable and pinch off into connected rings.

In aerodynamics, the Crow instability is an inviscid line-vortex instability, named after its discoverer S. C. Crow. The Crow instability is most commonly observed in the skies behind large aircraft, when the wingtip vortices interact with contrails from the engines, producing visible distortions in the shape of the contrail.

Trailing vortices do in fact sink by their mutual interaction, but they also move together, until they become unstable and pinch off into connected rings - the so-called Crow instability. There are literally thousands of pictures and studies documenting this behavior. Only when the tip vortices are in ground effect, when they are interacting with their below-ground images, do they travel away from each other.

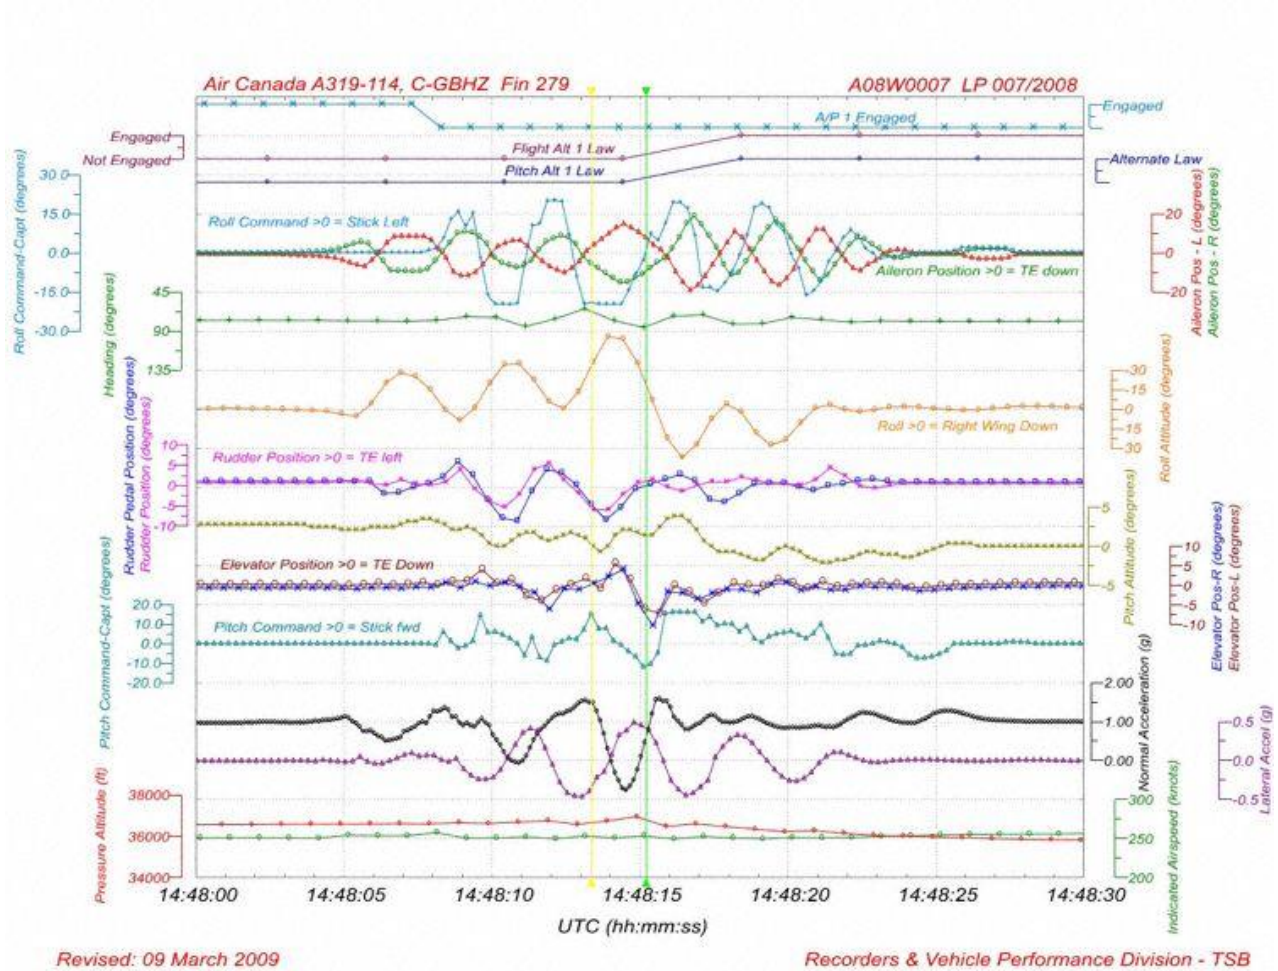
The flight data recorder showed that during the event vertical accelerations peaked in +1.57 G and -0.77 G, lateral accelerations reached 0.46 G left and 0.49 G right, and the side stick inputs were 90 degrees out of phase with the rudder inputs. The data is shown in Figure 4.

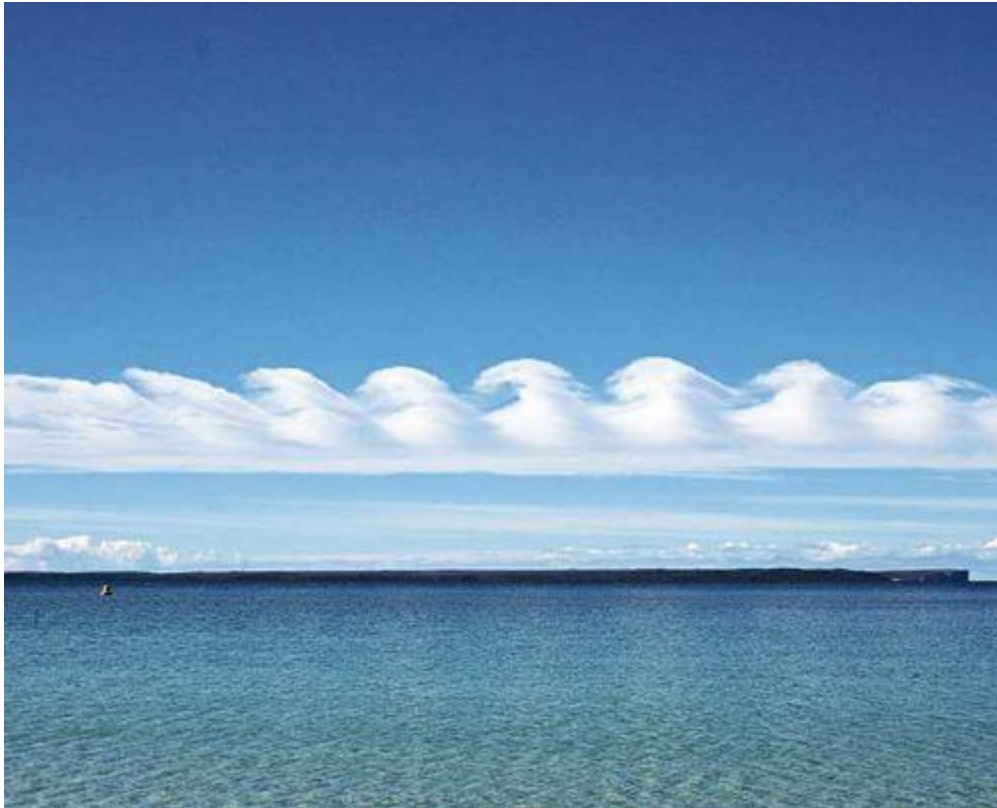
Figure 3. Kelvin-Helmholtz Cloud

Kelvin-Helmholtz clouds form between two layers of air traveling at different speeds. The top layer is a warm layer with low density. The bottom layer is a colder, dense layer. Eddies will develop along the boundary if the wind shear is sufficiently strong. A shearing instability is thus considered to exist at the boundary.

Kelvin-Helmholtz clouds are also called Billow Clouds. They resemble ocean waves breaking on a shore. The clouds provide a visible signal to pilots of potentially dangerous turbulence. These clouds and ocean waves are in fact caused by the

same shear instability mechanism, which is called the Kelvin-Helmholtz (KH) instability.

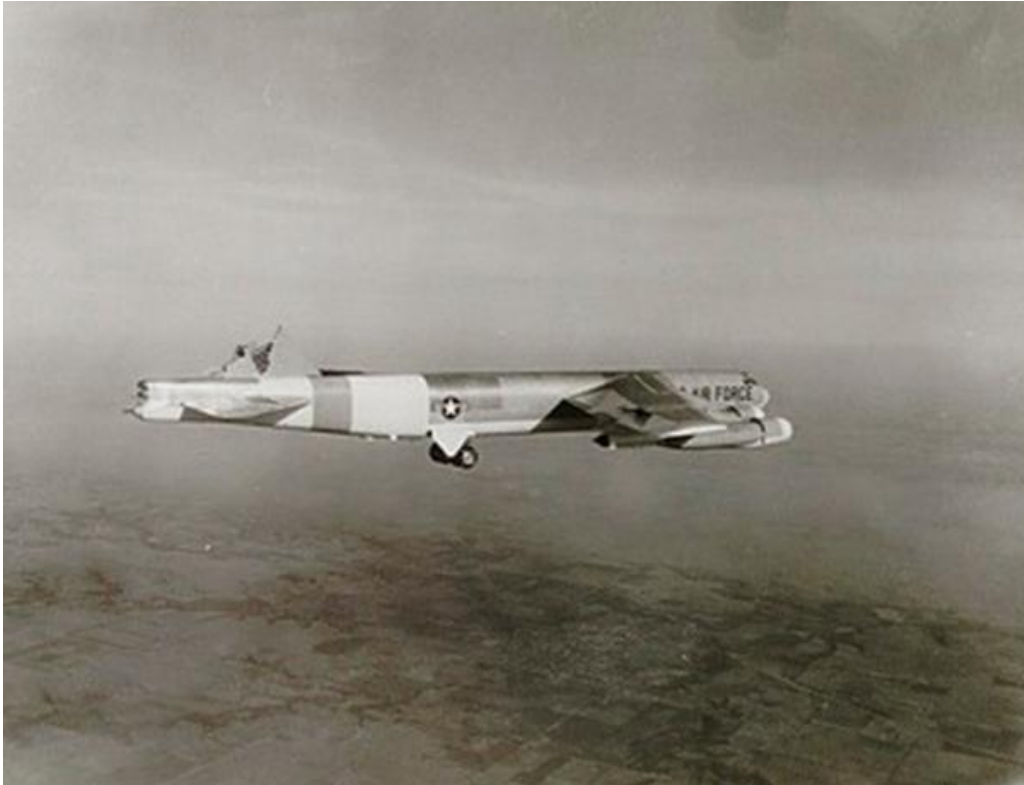
Figure 4. B-52 with Missing Vertical Stabilizer

- A B-52 had about three-fourths of its vertical stabilizer bitten off by 95-mph gusts at 14,300 feet over southern Colorado in 1964. The crew made a safe landing.
- A Douglas DC-8 cargo aircraft lost an engine and wingtip in mountain wave encounters southwest of Denver, in 1992. The aircraft landed safely with no crew injuries.
- A mountain wave ripped apart a BOAC Boeing 707 while it flew near Mt. Fuji in Japan in 1966. All 113 passengers and 11 crewmembers were killed in the disaster.
- A Fairchild F-27B lost parts of its wings and empennage at Pedro Bay, Alaska, in 1968. All 36 passengers and three crewmembers died.

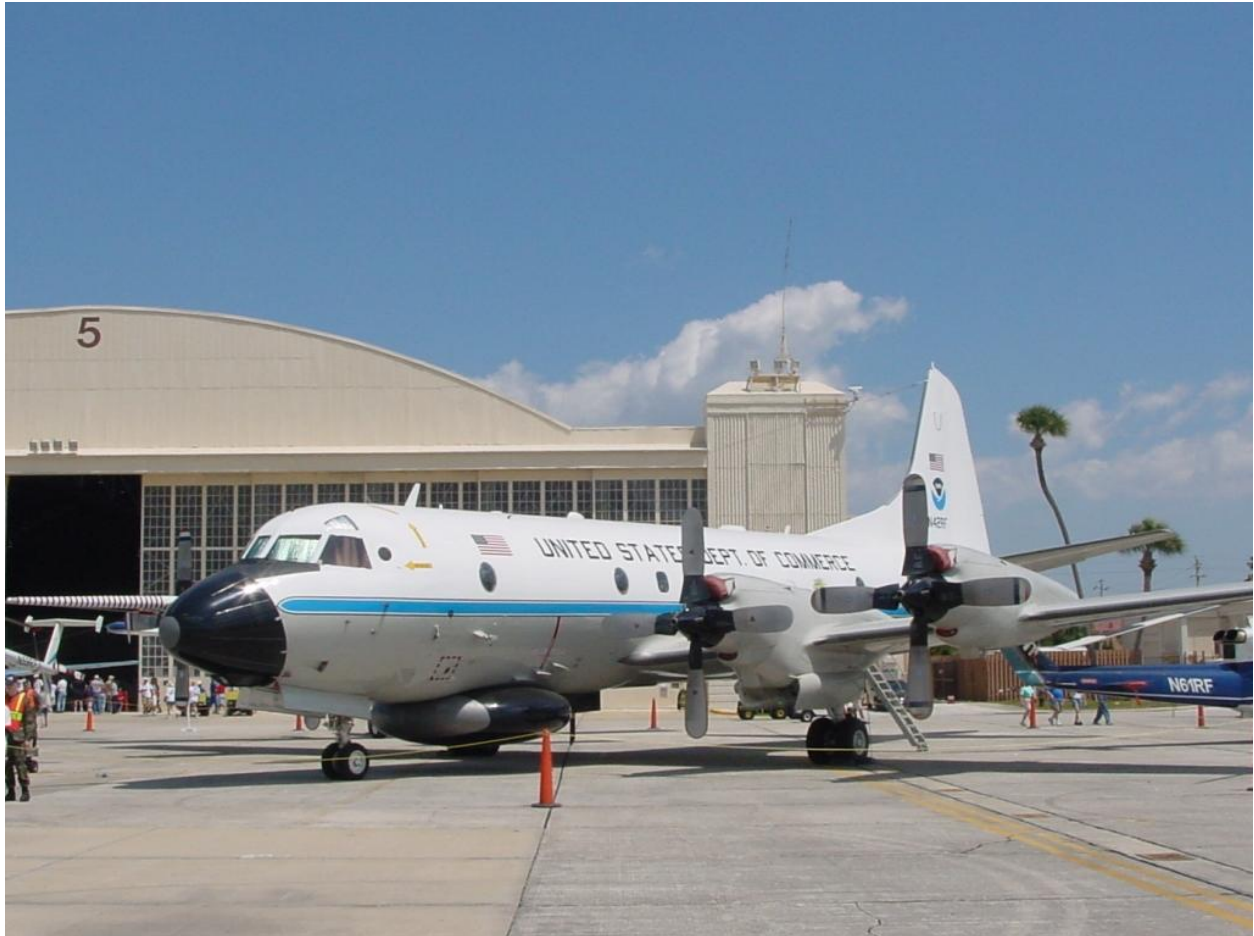
Figure 1. Lockheed WP-3D Orion, N42RF

NOAA has two WP-3D Orion turboprop aircraft, designated N42RF and N43RF. The aircraft participate in a wide variety of national and international meteorological, oceanographic and environmental research programs in addition to their widely known use in hurricane research and reconnaissance.

The aircraft are equipped with an array of scientific instrumentation, radars and recording systems for both in-situ and remote sensing measurements of the atmosphere, the earth and its environment.
