NASA Experience with Pogo in Human Spaceflight Vehicles

Dr. Curtis E. Larsen NASA Technical Fellow for Loads and Dynamics NASA Engineering and Safety Center Mail Code WE Johnson Space Center Houston, TX 77058 United States of America

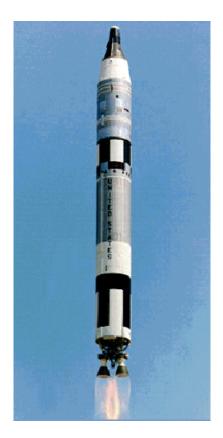
Figure 1. Gemini-Titan

propellants were thought to react much less violently in the case of an abort then the cryogenic propellants of Atlas, so ejection seats were considered compatible with the Titan II. The increased thrust of the Titan II almost two and one-half times that of the Atlas, also made other Gemini spacecraft improvements more feasible. Thus Gemini and Titan seemed to be a perfect match.¹

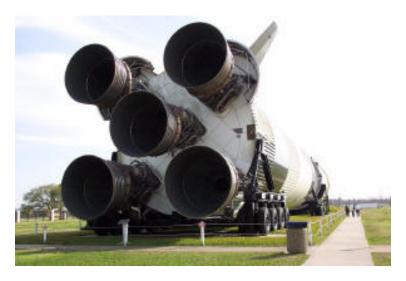
Figure 4. Saturn V First Stage S-IC

The second unmanned Saturn V, designated as AS-502 or Apollo 6, launched on April 4, 1968, but unexpectedly experienced pogo at 5 Hz between 105-140 seconds during first stage (S-IC) boost with 0.60 g maximum acceleration at the command module and 0.33 g at the aft of the vehicle.³ The second and third stages of flight also experienced problems with failures of the J-2 engines unrelated to the first stage pogo.⁹ 9The acceleration response recorded at the lunar module simulator during the first stage pogo event is illustrated in Figure 5.¹⁰

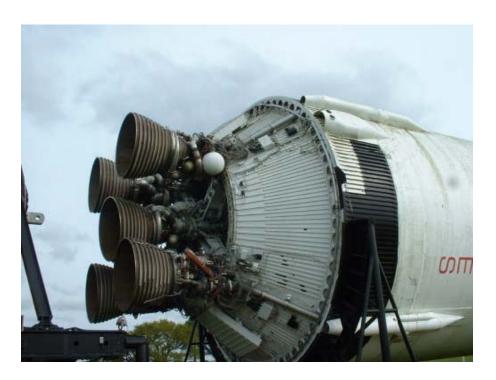
Figure 8. Saturn V Second Stage S-II Close up, J-2 Engine Cluster¹⁵

Apollo 8 (AS-503), the third Saturn V and first manned flight (Apollo 7 flew on a Saturn IB), successfully demonstrated the effectiveness of this pogo mitigation for the S-IC first stage. However, perhaps even more unexpectedly than the first stage pogo, on this mission the S-II second stage experienced pogo as reported by the command pilot at about 50 seconds before engine cut-off. Data analysis revealed an 18 Hz vibration of the center engine of the five engine J-2 cluster. Mounted on a crossbeam structure, the center engine was vibrating with the liquid oxygen (LOX) tank bottom. The magnitude at the crew cabin was actually quite small and no threat, but the local amplitude at the engine mount posed a threat the supporting cross beam structure.^{3,10}

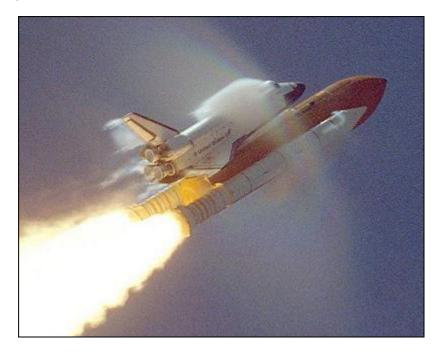
Figure 13. Space Shuttle

The Space Shuttle Phase C/D development began in 1972 with the experience of Apollo 13 still fresh in memory of NASA program managers. The desired rapid turnaround of the Shuttle fleet also influenced the program management attitude regarding pogo. The Johnson Space Center's first co-chair for the Shuttle pogo prevention panel, Dr. Hal Doiron, was told the problem should be fixed "with a sledge hammer". Recurring pre-mission debates on whether different payload dynamics would erode small stability margins were going to be unacceptable to management. An operational approach similar to an airline was desired, just as wing flutter is not an issue for any flight within an aircraft's operational envelope, and is not affected by structural dynamic cargo changes.^{4,15}
