# THRESHOLD

Pratt & Whitney Rocketdyne's engineering journal of power technology

## POGO

by Jim Fenwick, Spring 1992

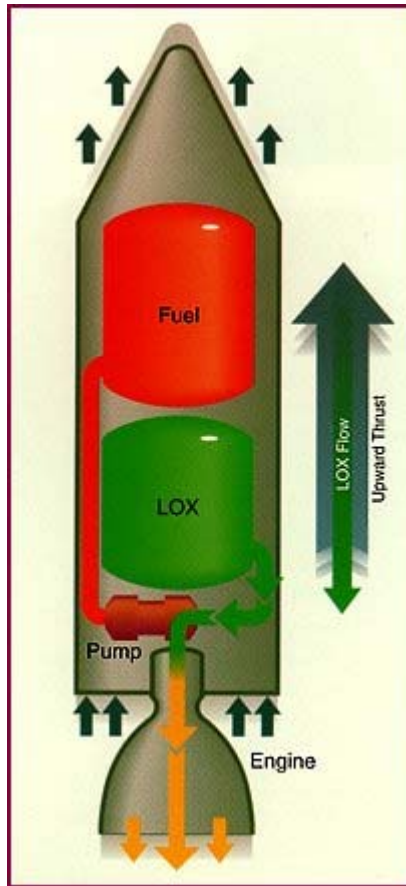
*The pogo phenomenon: as the engine moves upward cyclically, propellant fluid is forced into the turbopump. This excess fluid is converted into unwanted thrust which tends to move the engine even farther. The net result could be felt in the spacecraft or, worse, could lead to structural failure in the booster.*

The problem involved the vehicle structure, the column of propellant in the feed line to the engine, and the engine itself.

As the engine moves upward, pressure at the turbopump propellant inlet increases, producing a force that acts upward on the propellant and downward on the engine and structure. This increased pressure causes additional flow into the engine that is burned in the main thrust chamber, and in turn, produces an additional upward force on the vehicle structure. Thus, if the upward force from the engine is greater than the downward force at the engine fuel inlet, the engine acts like negative structural damping with potential for pogo. To result in instability or divergent oscillation may also require frequency matching or tuning of the feed system resonance with a structural resonance. Since tuning and detuning occur naturally during a flight as the propellant in the tanks is consumed, the phenomenon itself could be transient.

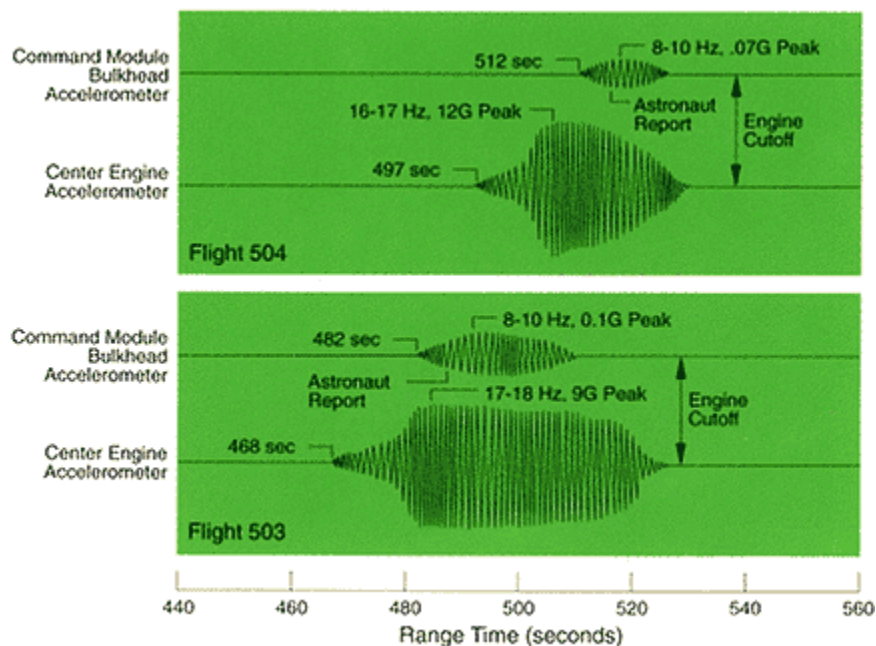
*Data recorded from on-board accelerometers on the first two Saturn manned flights showed pogo as measured at the source, specifically, the center engine mount and the response at the crew module.*

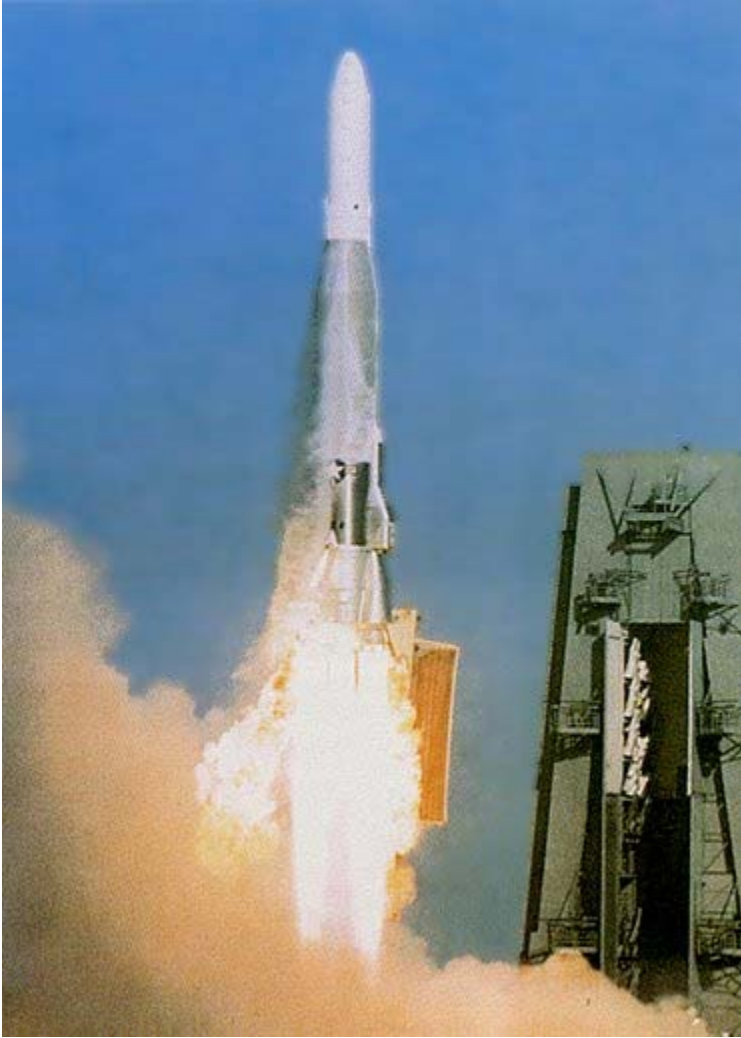
*The balloon-like stainless steel Atlas vehicle provided a soft ride for its passengers, but it, too, had its share of pogo.*

The Atlas is unique as a vehicle, built like a huge stainless steel balloon, rather than with conventional ribs and stringers. It apparently gave a soft ride to its passengers, but it too had its share of pogo.

Early Atlas launches showed 5- to 6-Hz vibrations during the first 20 seconds after liftoff that grew to several Gs at the engine before subsiding. Analyses and component testing showed that it was a new phenomenon, subsequently named *gas-pogo* or *bloating*.

In normal procedures the upper (oxidizer) tank was given a quick shot of pressurizing gas just after liftoff when the tank was almost completely filled with liquid. The tank would swell slightly and extend axially like a balloon. The axial frequency of the vehicle was about 5 Hz at liftoff. Since the tank pressure regulator was at the aft of the big vehicle and near the supply of warm helium, the gas pressure sensing line had to run the entire length of the vehicle. The 'organ pipe' frequency for this long pressure sensing line also turned out to be about 5 Hz. This tuning continued to excite the structure until enough liquid was pulled out of the tank to detune the structural frequency.

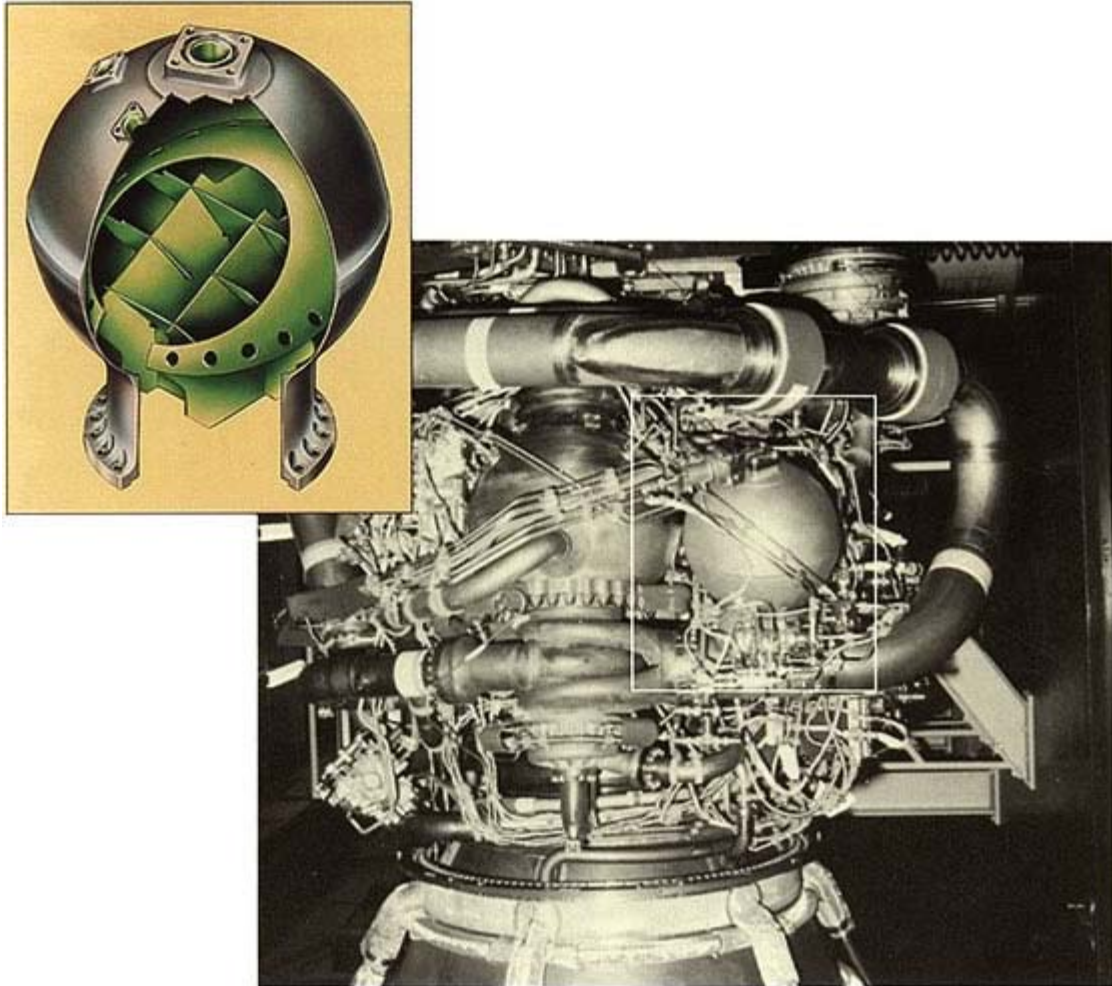
*The SSME pogo suppressor is located just upstream of the high-pressure oxidizer turbopump. Flow of gaseous oxygen (GOX) can be routed through the suppressor, where baffles prevent liquid motion that can lead to condensation of the hot GOX bubble that forms at the inlet.*

new approaches, as well as careful re-evaluation of old ones to assure adequate data at tolerable costs, this in order to avoid any potential problem which could incur a remedial cycle in the development process. So for the first time a suppresser was designed as part the engine, here as a broad-band filter, as opposed to a part of the vehicle designed to change the feed line frequency.

The suppression system developed for the shuttle is about the size of a basketball and is teed off the main LOX duct just upstream of the high pressure oxidizer turbopump. While charged with helium at engine start and cutoff, for most of the flight hot (400°F) gaseous oxygen (GOX) is in direct contact with cold (-300°F) LOX. The mixture of GOX and LOX is continuously bled from the suppresser to control the gas volume and thereby the feed system dynamics that prevent pogo. Then the mixture is reintroduced into the feed line upstream of the engine so that all the gas condenses.
