Assessment of the modes of failure of retaining structures from
previous major earthquakes:
Caltrans Seismic Design Analysis of Retaining Walls Project

Tadei Shayo

9/4/2009

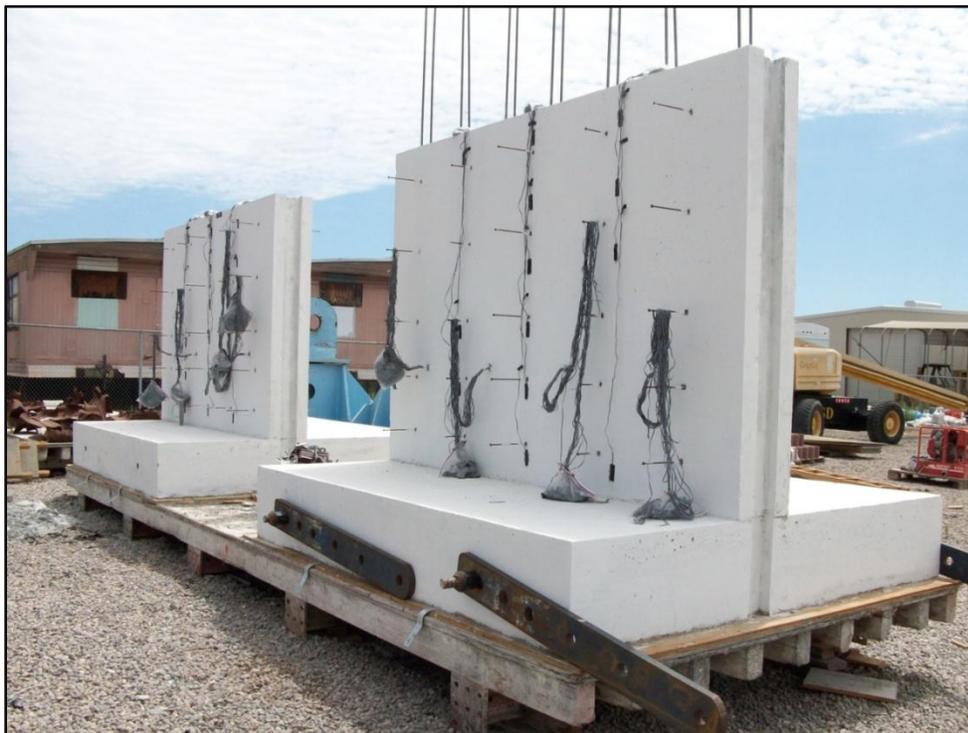
Figure 4: Photo of the retaining walls with strain gauges attached. Note the rebars for the infill sound barrier on top of the nearest wall.

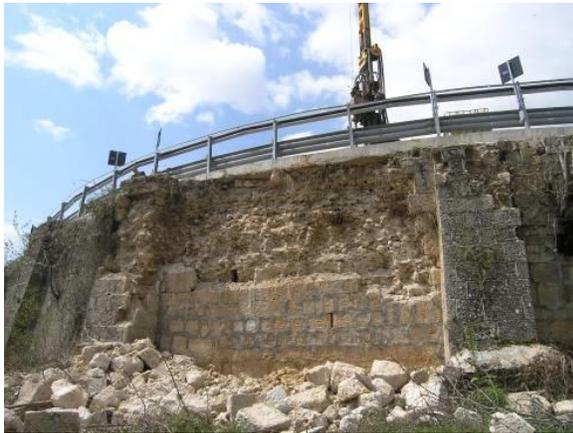
Figure 9: The masonry infill of this wall failed from the L'Aquila earthquake (GEER).

The magnitude 6.3 quake in L'Aquila caused significant damage to masonry infill-type retaining walls, as can be seen in the photos on this page. However, it was observed that some walls incurred only major cracks but did not undergo total collapse. The significant contrast seen here (some walls collapsing while others only failing through cracking) can best be attributed to the type of construction used for the various retaining walls. This is because the L'Aquila earthquake had the smallest magnitude, PGA and PGD. The collapse of the masonry infill was also caused by the high frequency exhibited by this quake as compared to the other earthquakes mentioned in the graphs.

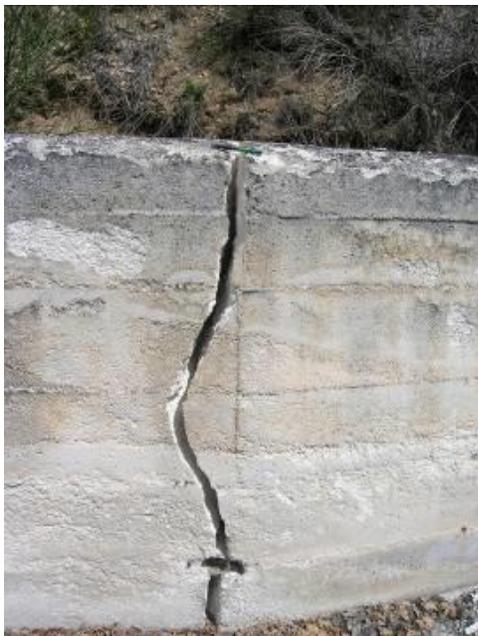
Figure 10: Cracks due to the L'Aquila earthquake (GEER).

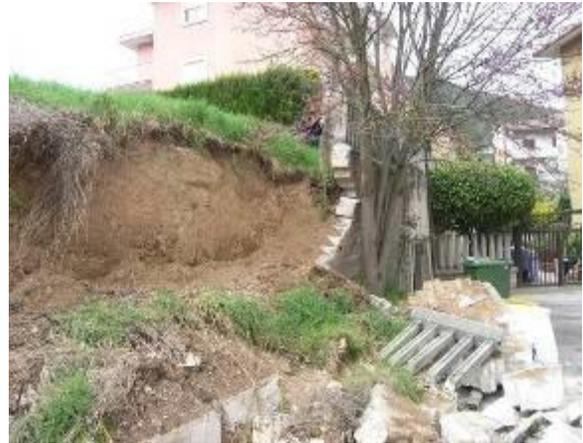
Figure 11: Total collapse of a wall from the L'Aquila earthquake (GEER).

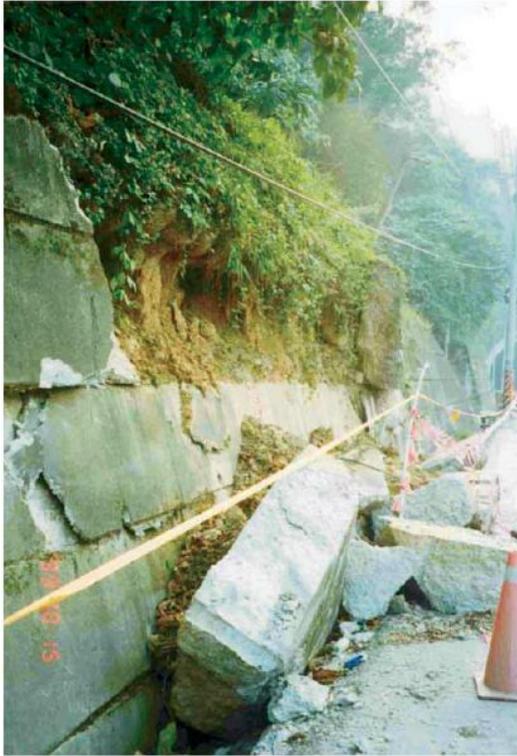
Figure 12: This retaining wall was not reinforced; it failed at the mortar joints (Fang 1144).

The soil which the wall in **Figure 12** was supporting was used for a plantation. This being so, one sees that liquefaction might have occurred underneath the wall (Fang 1148). *This combined with the soft characteristic of the soil, are primarily what caused the wall to sink into the ground.*

The Chi-Chi quake had a ground displacement comparable to the 1994 Northridge and the 2009 L'Aquila earthquakes. It also had a frequency similar to that of the L'Aquila one. A quick observation of the photos of retaining structures from the Chi-Chi and the L'Aquila earthquakes show a *striking similarity* in the type of damages incurred by retaining walls. The walls share the same type of block construction, and in both

earthquakes, the top half of the walls collapsed.

Thus, it appears that retaining walls built with unreinforced masonry infill will suffer considerable damage on earthquakes with magnitudes similar to those of the Northridge and the L'Aquila earthquakes (6.3-6.7) and with similar frequencies as well.

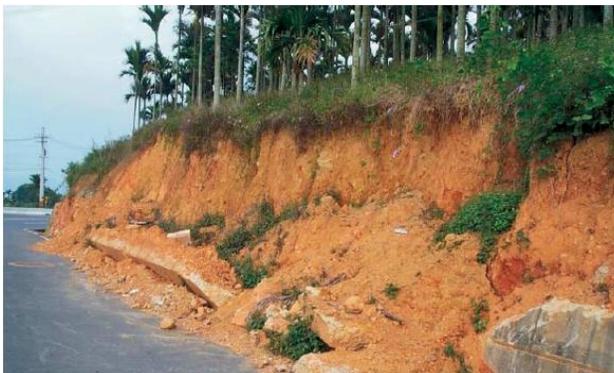
Figure 13: This wall sank into the earth due to insufficient pressure support at its toe (Fang 1148).

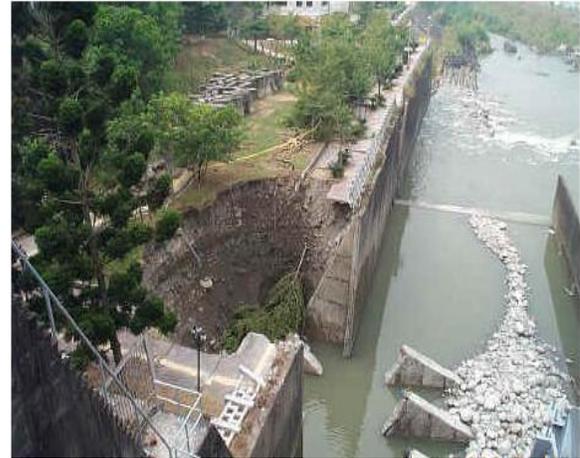
Figure 14: Shih-Kang dam spillway failure (USBR 2009).

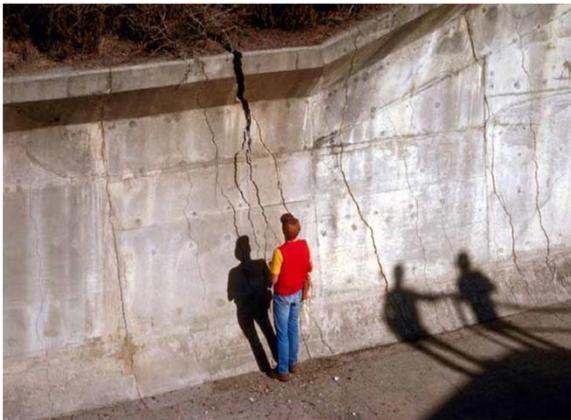
Figure 15: Loma Prieta: this retaining wall sustained major cracks (Wikipedia).

As can be seen in **Figure 13**, that section of the retaining wall only incurred major cracks, but remained in good structural condition to perform its function. According to a 1995 report published by the AASHTO, 20 reinforced earth retaining structures in the San Francisco area did not suffer damage during the 1989 Loma Prieta earthquake. Out of these twenty, only three were designed to withstand some amount of seismic activity.

As is indicated in the bar charts, the relatively *short* duration of this quake is the most appealing characteristic which favored this small amount of damage.

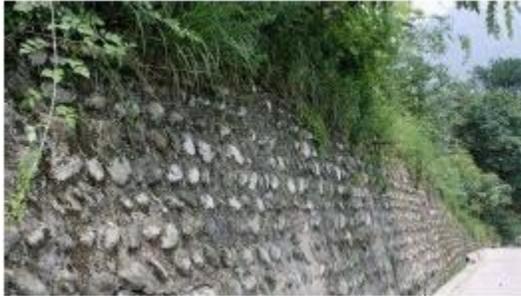
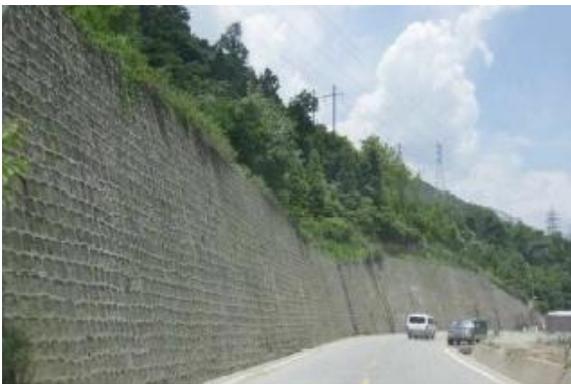
Figure 16: Stone and concrete retaining wall. (Source unknown).

Figure 17: Photo of another retaining wall. (Source unknown).

Although the 2008 Sichuan quake had the largest magnitude, PGA, PGV, PGD, as well as the longest duration of ground shaking, it caused the least amount of damage to retaining walls. Retaining walls such as the ones shown in the photos above performed very well even though they are not reinforced.

This fact can best be explained by the soil structure around the retaining walls. Previous analysis reports of this

earthquake state that there was not much liquefaction in the soil (Mageau 12).

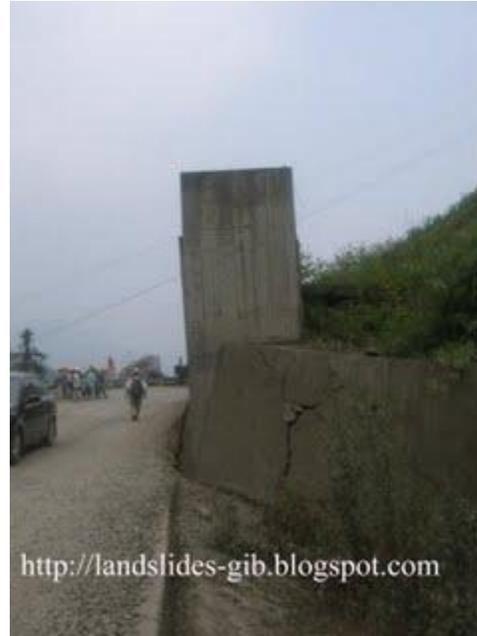
Figure 18: Photo of a reinforced concrete retaining wall.

Note: Reinforce concrete retaining walls are not popular in this area; however, this wall performed well and only had cracks.

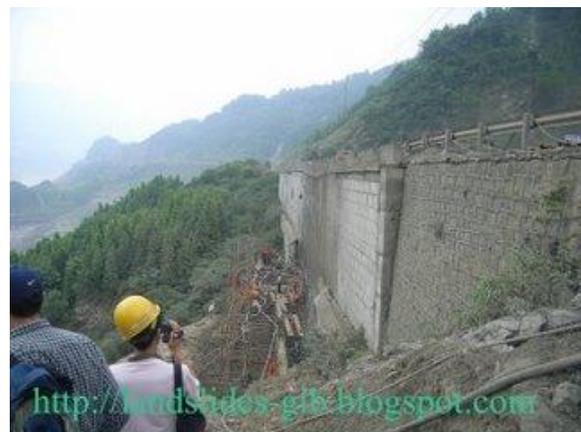
Figure 19: Embankment which had a small settlement at the middle.

Note: Two reinforced soil embankments were observed; the other one (not shown) was not damaged at all because it contained more reinforcement (anchors and concrete lattice structure) which were added during a previous repair (landslide-gib.blogspot.com).

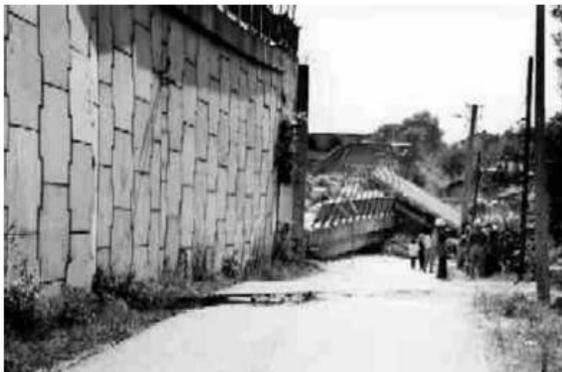
Figure 20: Reinforced earth wall after earthquake (Sankey 3).

This retaining wall remained sound after the Kocaeli earthquake even though the bridge next to it collapsed (Sankey 3). This

particular wall was designed to resist horizontal accelerations of up to 0.20g (Sankey 3). However, the reported peak acceleration around the location of this wall was 0.40g, yet the wall remained practical (Sankey 3). According to Sankey, if this wall was to be designed to withstand the 0.40g acceleration, it would have required four times the amount of reinforcing rebars compared to the original design for 0.20g. However, since the wall was able to resist seismic loads multiple times of what it was designed for, it is not always necessary to put the full amount of reinforcement in order to meet a certain design criterion (Sankey 3).
