September 2001 Newsletter

The X-43A Flight Failure By Tom Irvine

THE TACOMA NARROWS BRIDGE FAILURE By Tom Irvine

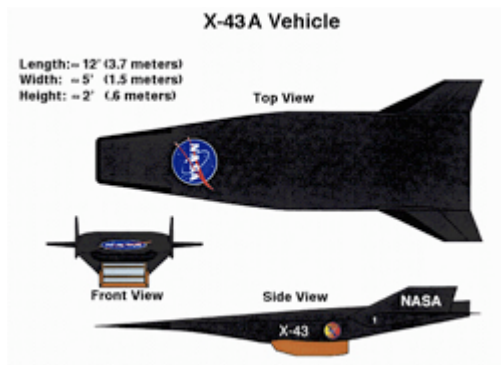
Figure 1. The X-43A Vehicle

Unfortunately, the X-43A mission was lost after moments after the X-43A and its booster rocket were released from the wing of the B-52 carrier aircraft. Following booster ignition, the combined booster and X-43A experienced structural failure and deviated from its flight path. Video footage showed that the Pegasus starboard fin detached during the failure. Whether the fin broke as a cause or effect of the failure was not immediately clear. Note that the fins are moveable fins that are used to steer the vehicle.

As of late August, the focus of the ongoing failure investigation is the fin control algorithm. The aerodynamic forces encountered in flight were more severe than the preflight predictions. The control gain factors were thus set for a less severe environment. As a result, the fins attempted to over-steer vehicle. The aerodynamic

forces then caused a loss of control and a structural failure.

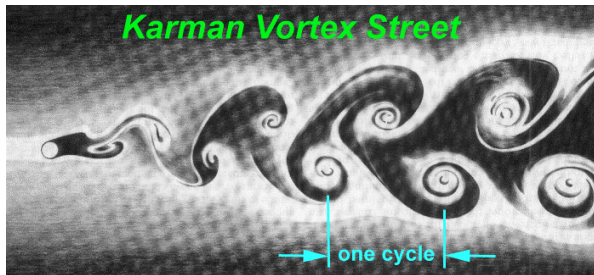
Figure 3. Vortex Shedding around a Spherical Body

Theodore von Karman, a famous aeronautical engineer, was convinced that vortex shedding drove the bridge oscillations. A diagram of vortex shedding around a spherical body is shown in Figure 3. Von Karman showed that blunt bodies such as bridge decks could also shed periodic vortices in their wakes.

A problem with this theory is that the natural vortex shedding frequency was calculated to be 1 Hz. This frequency is also called the "Strouhal frequency." The torsional mode frequency, however, was 0.2 Hz. This frequency was observed by Professor F. B.

Farquharson, who witnessed the collapse of the bridge. The calculated vortex shedding frequency was five times higher than the torsional frequency. It was thus too high to have excited the torsional mode frequency.

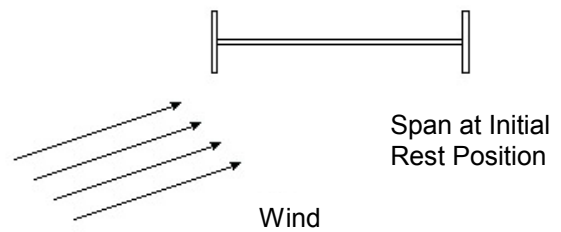
Assume that the wind direction was not perfectly horizontal, perhaps striking the bridge span from below, as shown in Figure 4a.

Thus, the bridge is initially at an angle-of-attack with respect to the wind. Aerodynamic lift is generated because the pressure below the span is greater than the pressure above. This lift force effectively places a torque, or moment, on the bridge. The span then begins to twist clockwise as shown in Figure 4b. Specifically, the windward edge rotates upward while the leeward edge rotates downward.

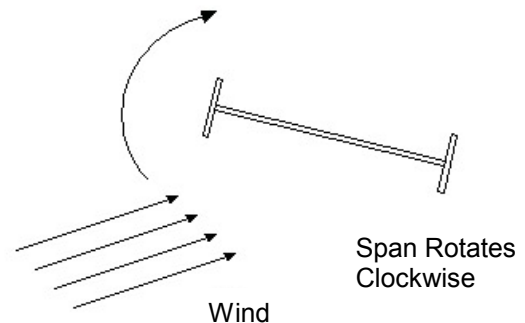
Figure 4b.

The span has rotational stiffness, however. Thus, elastic strain energy builds up as the span rotates. Eventually, the stiffness moment overcomes the moment from the lift force. The span then reverses its course, now rotating counter-clockwise

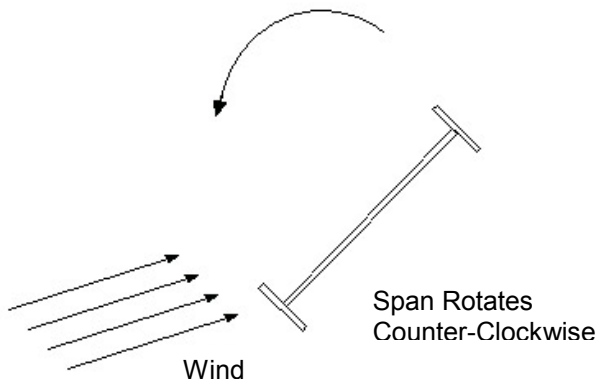
The span's angular momentum will not allow it to simply return to its initial rest position, however. The reason is that there is little or no energy dissipation mechanism. Thus, the span overshoots its initial rest position. In fact, it overshoots to the extent that the wind now strikes the span from above as shown in Figure 4c. The wind's lift force now effectively places a counter-clockwise moment on the span.

Eventually, one of two failure modes occurs. One possibility is that the span experiences fatigue failure due to an excessive number of stress reversals. The other is that the angular displacement increased in an unstable manner until the material is stressed beyond its yield point, and then beyond its ultimate stress limit.

In reality, these two failure modes are interrelated. For example, accumulated fatigue effectively lowers the yield and ultimate stress limits. Regardless, the bridge collapses.
