Recognition and Correction of Sonic Fatigue Damage in Fighter Aircraft

Mr. Salvatore L. Liguore, Dr. Theodor H. Beier

The Boeing Company, PO Box 516
St. Louis, MO 63166-0516, USA

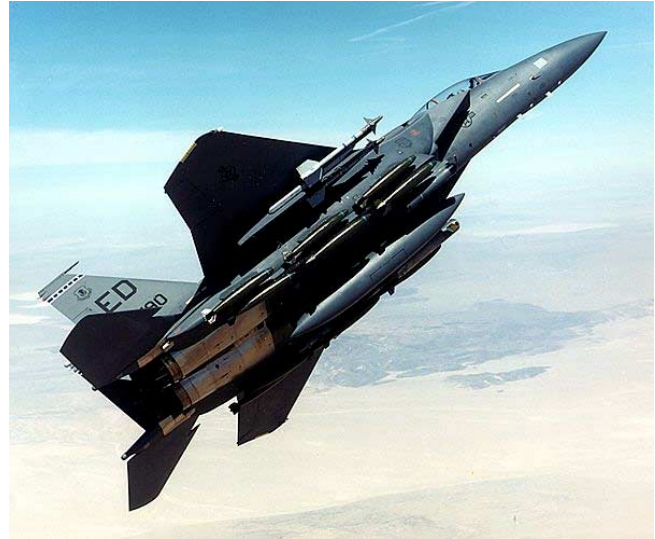
On fighter aircraft, secondary structures are lightly loaded during maneuvers, but they still experience cracking primarily due to dynamic loads from buffet, flow-induced noise, shock/boundary layer interaction, and turbulence. Acoustic loads are highest during high speed and low altitude missions for the lower surface and during high angle of attack maneuvers for the upper surface. On the lower surface, turbulent flow forms around external stores, Figure 1, and will be used as an example source of damage is discussing repairs. This noise is characteristically high in frequency (200 to 1000 Hz) and broad band in nature as will be shown in Figure 4.

Figure 1. On the Lower Surface, Turbulent Flow Forms Around External Stores

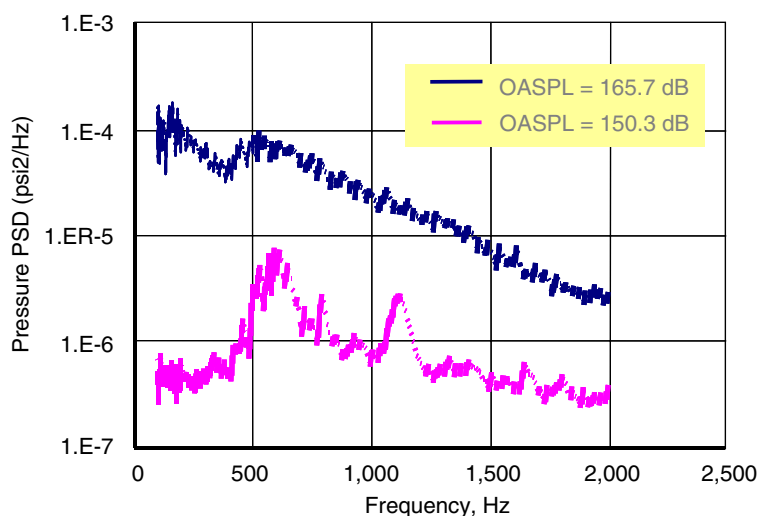
The increase in the acoustic spectrum on the fuselage skin at the critical locations from the addition of the pod may be seen in Figure 4. It may be noted that the spectrum levels are high over a wide frequency range. Therefore, strengthening the panel, which will increase its natural frequency, will not help, and in fact a change from 300 Hz to 500 Hz would be detrimental.

Other excitation sources mentioned herein have levels of similar magnitude. Engine exhaust plume spectra may be in the 165 dB to 170 dB range, and relatively flat over a wide range of frequencies. Acoustic spectra from engine inlets and weapons bays will

Figure 4. Incident Sonic Spectrum, With and Without Stores

have high broad-band levels, and in addition contain pure tones of very high amplitude. However, it will be impossible to tune the structural frequencies to avoid the tones because they change frequency with engine speed in the inlet case, and with Q in the weapons bay case.

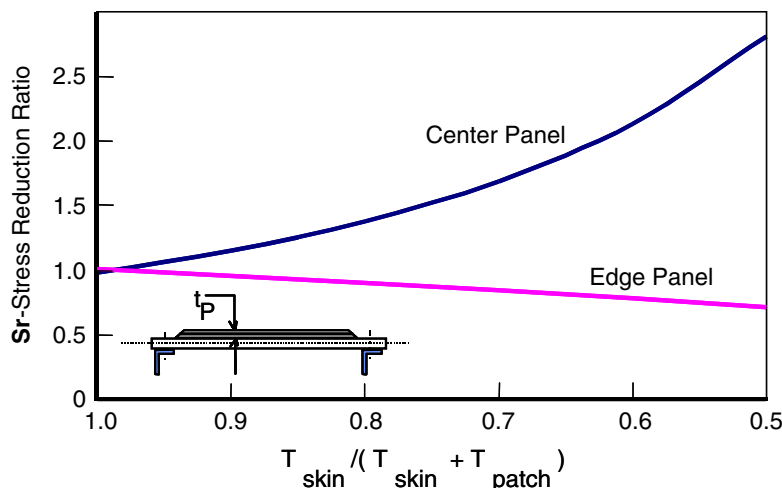
Reinforcement - The problem with repairs that involve stiffening only is that fatigue damage often appears on adjacent structure, because the dynamic energy is still present. Doublers mass load the substructure and cause higher dynamic bending moments at the panel edges, which may change the response of near-by panels. See Figure 5, which shows the reduction ratio in stress for the patch application as a function of doubler thickness. It may be noted that as the doubler thickness increases, the reduction ratio at the panel edge decreases below 1.0, which indicates an actual stress increase. For example, if a panel is repaired with a doubler of equal thickness, the stress at the panel center is reduced, but the stress ratio at the edge is 0.75, which is a stress increase of 33%. This will likely cause the failure to migrate to the substructure.

Figure 5. The Effect of Skin Reinforcement on RMS Panel Response

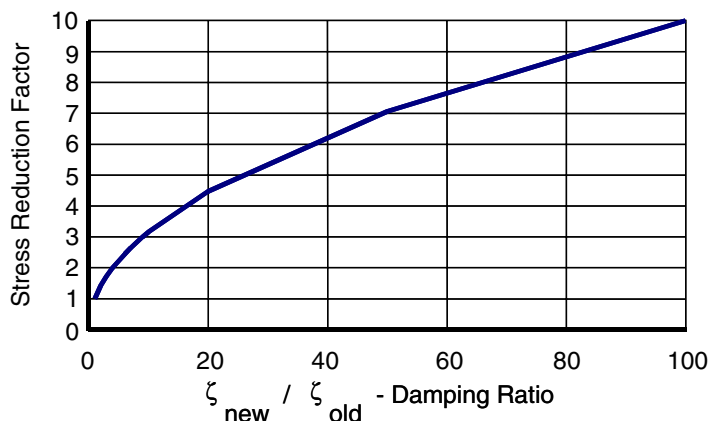
In linear dynamics systems, damping is inversely proportional to the response. Hence, as the damping increases the peak response decreases proportionally. Under broad band random vibration, the response is inversely proportional to the square root of the damping. Hence, the damping would have to be quadrupled in order to decrease the root mean square (RMS) response by 50%. This relationship is shown graphical in Figure 6. Referring to the figure, if the damping is increased by a factor of 6 to 7, a factor which can be easily achieved, the stress reduction in the panel is 2.5 as with the doubler. Unlike the simple doubler, the stress at the edge is also decreased by a similar amount.

Figure 6. The Effect of Damping on Single Mode RMS Response

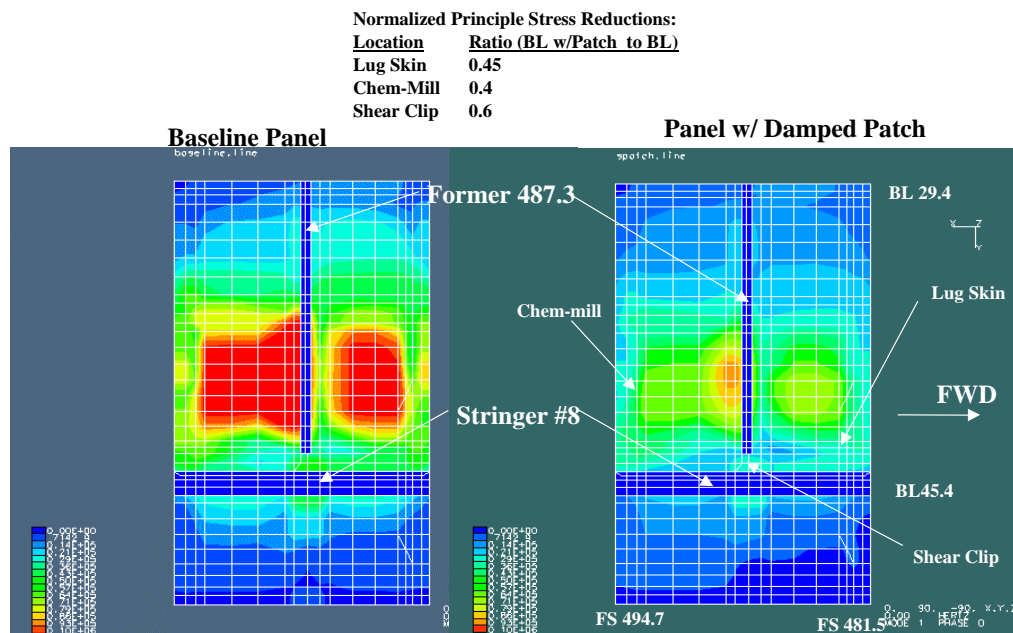
The purpose of the damped doubler is to reduce loads in the skin and in the former through damping. The design was verified through finite element analysis. The damping performance of the patch was determined through modal strain energy analysis¹⁴. The panel was analyzed using random response analysis to determine overall RMS loads reduction, Figure 9. The contour plot shows how the stresses in the skin panel are expected to change. Large reductions are expected in the skin panel with smaller reductions at the edges. The modal damping predicted by the analysis was on the average of $\zeta = 5\%$ for the lowest 5 modes at the temperature of interest, which is an increase of over 4.

Figure 9. Random Vibration Analysis of Panel with and without Patch

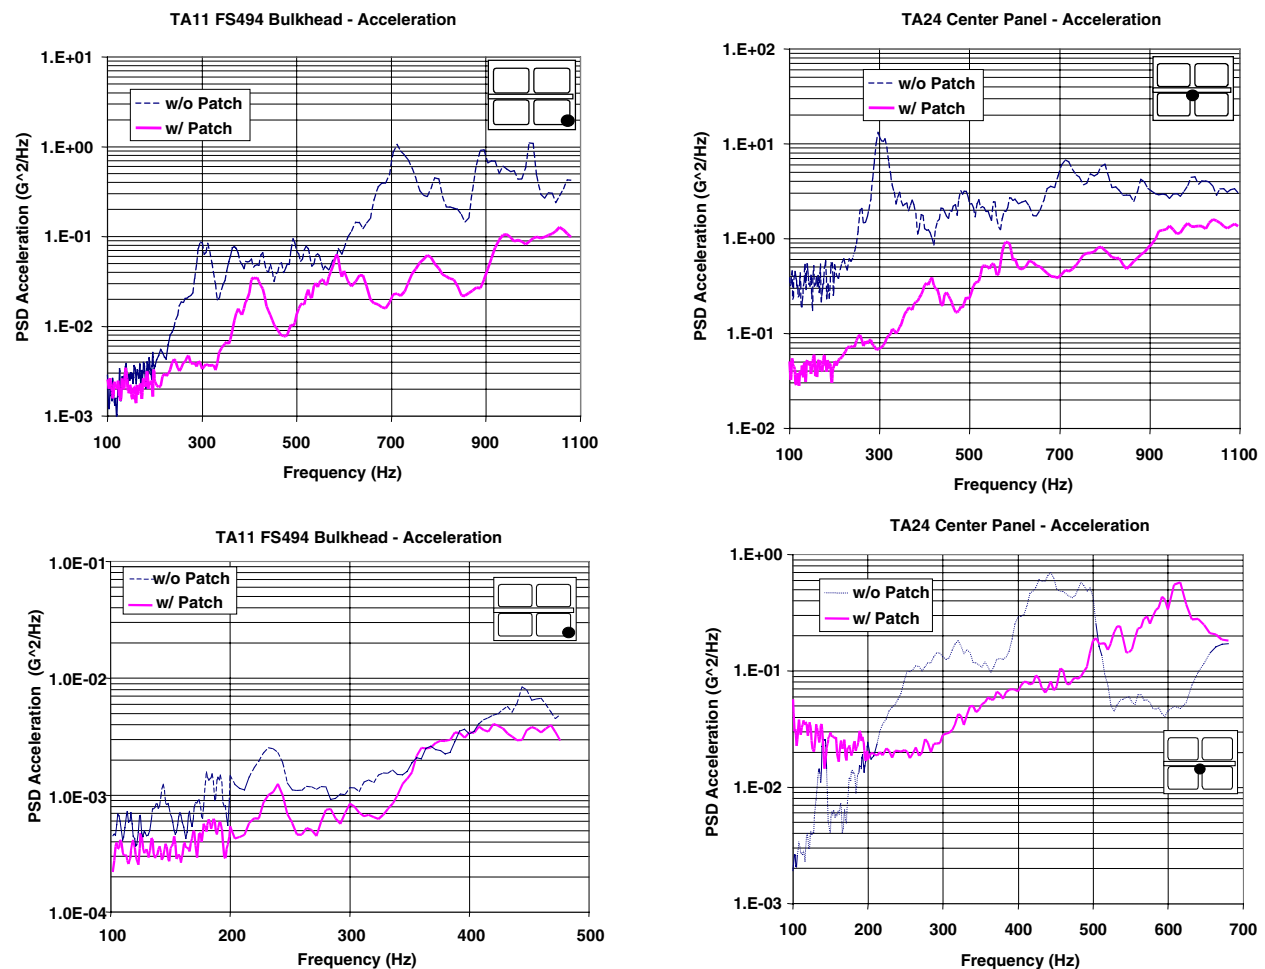
instance, the temperature varied 20-F to 105-F. The absolute static pressure varied from 5-psia to 18-psia. The comparison of patched to unpatched response was made with the strain gages and accelerometers. On an overall basis, the acceleration showed the most dramatic response reductions for the patch configuration. These PSDs plots are shown in Figure 11.

Figure 11. Comparison of Acceleration PSDs w/ and w/o Patch

(Note: The top figures are w/ external stores and the bottom figures are w/o external stores.)
