August 2011 Newsletter

## Republic XF-84H Aircraft Sound & Vibration

## Aircraft Landing Shock by Tom Irvine

## Turbofan Engine Buzz-Saw Noise by Tom Irvine

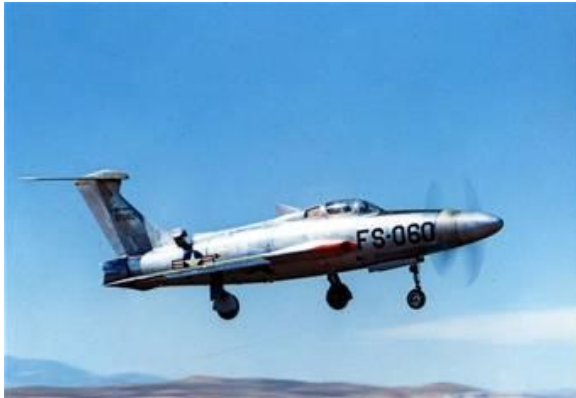
Figure 1. XF-84H Prototype

The XF-84H was built from a modified F84F airframe with a 5,850 hp Allison XT40-A-1 turboprop engine. The T40 was a pair of 2,750-shaft-horsepower T38 engines inside a common case.

The propellers had variable pitch for thrust control.

The XF-84H was also the first airplane to carry a ram air turbine, which automatically deployed from a compartment in the dorsal fin and pinwheeled in the airstream to provide extra electrical and hydraulic power.

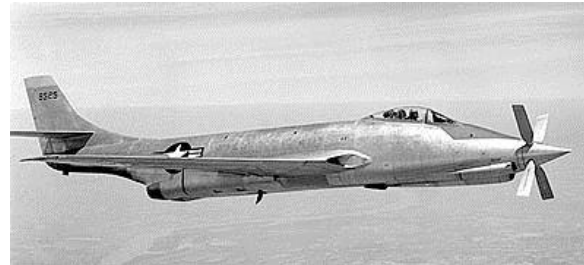
Figure 2. XF-88B

The XF-88B was powered by a nose-mounted Allison T38 turboprop engine and two turbojets. Typical takeoffs and landings were made with the propeller blades feathered and clocked in the X position. Propeller ground noise was thus not an issue.

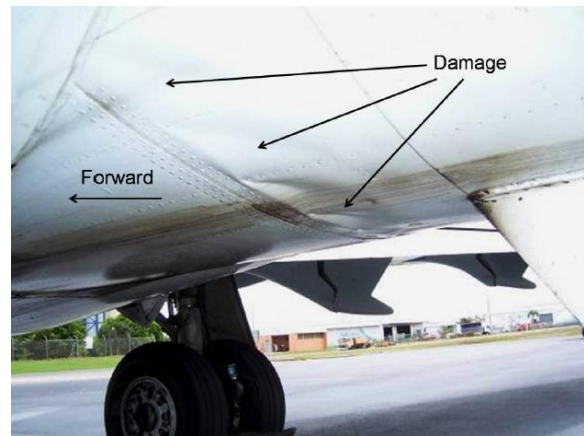
Figure 2. Fuselage Skin Panel Damage

The damage occurred in a Boeing 717-200 due to hard landing, Reference 4.

Ref.	Aircraft	Sink Rate (ft/sec)	Accel (G)	Damage
4	Boeing 717-200	17.9	3.6	Rear fuselage skin panels deformed and wrinkled.
5	Airbus A340-600	18.3	3.0	Serious damage to undercarriage
6	Boeing 747-436	17.8	2.86	Structural damage to the fuselage keel beam in the area of the landing gears, and slight <i>out-of-round</i> damage to some of the wheel hubs. <i>Quilting</i> and <i>rippling</i> of the skin panels just aft of the wing.
7	Boeing MD11	18 to 20	2.6	Right landing gear collapsed. Right wing separated.
8	Airbus A340-311	16.7	2.17	Damage to tires and landing gear hardware. No structural damage.
9	Airbus A321-2009	9.1	1.91	Tail-strike & other structural damage
10	Boeing 737-210C	6.7	1.86	Substantial damage. Left nose tire burst.

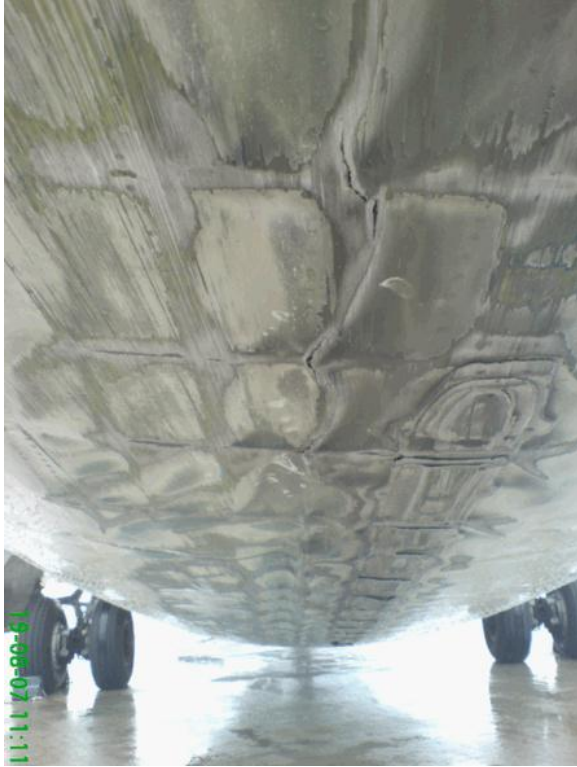
Figure 3. Tail-strike Damage

Swiss-operated BAE Systems Avro RJ100 at London City Airport, August 18, 2007.

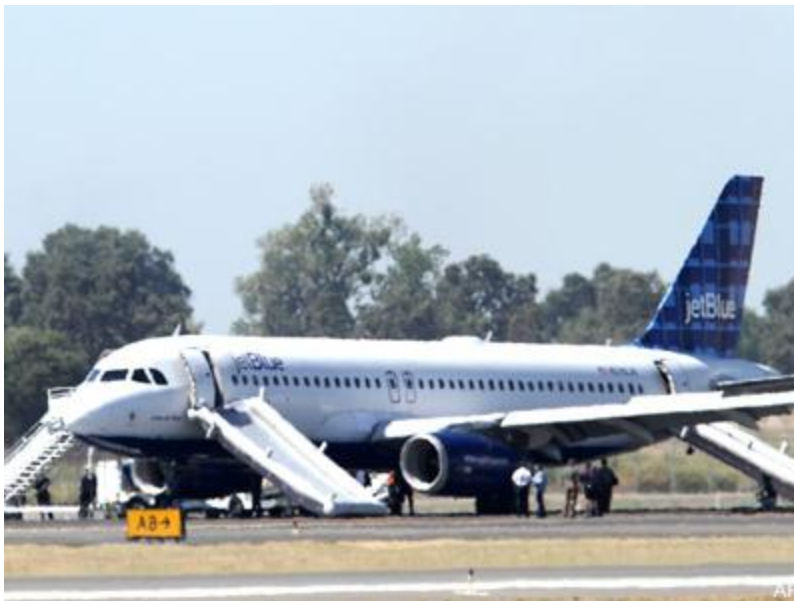
Figure 4. JetBlue Airbus A320, Hard Landing, Sacramento, August 26, 2010

The hard landing occurred because the parking brake was engaged, either through pilot error or a technical fault. Four main landing gear tires blew out, and a minor tire-related fire erupted. The passengers exited via emergency slides after the aircraft came to a standstill. Seven people had minor injuries from either the landing shock or the rapid evacuation, per NTSB report WPR10IA430.

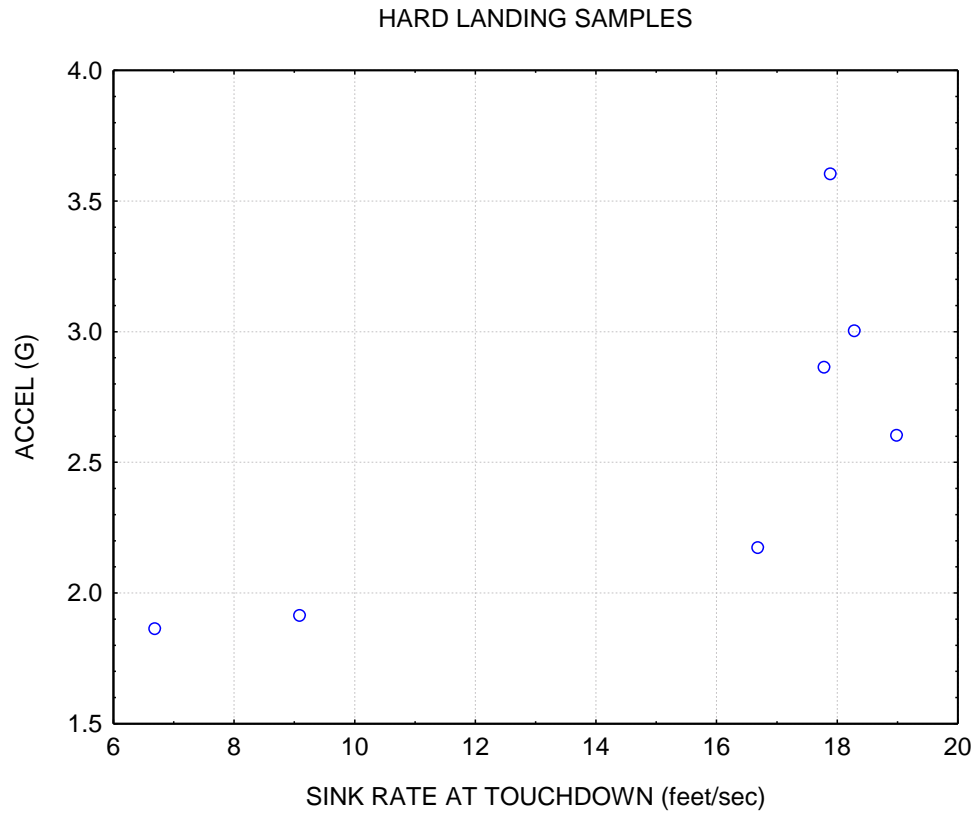
The data points from Table 2 are plotted in Figure 5.

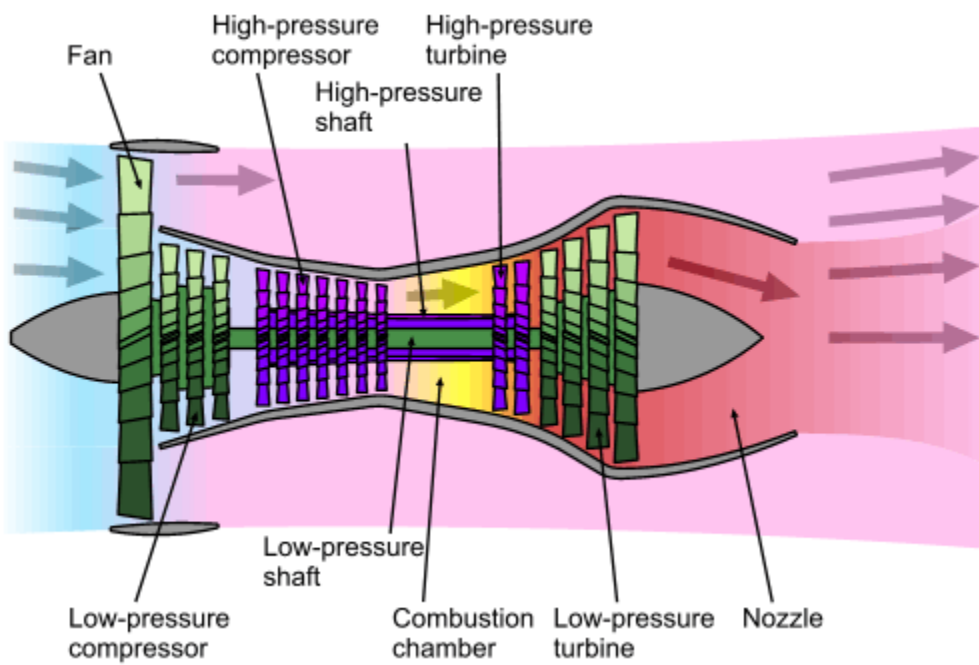
Figure 4. Turbofan Engine Subsystems

The engine has two concentric rotors, which operate at different speeds.

The low-pressure shaft drives the fan and the low-pressure turbine.

The other shaft drives the compressor and high-pressure turbine.

The turbofan engine noise sources and radiation patterns are shown in Figures 2 and 3. The engine subsystems are given in Figure 4.

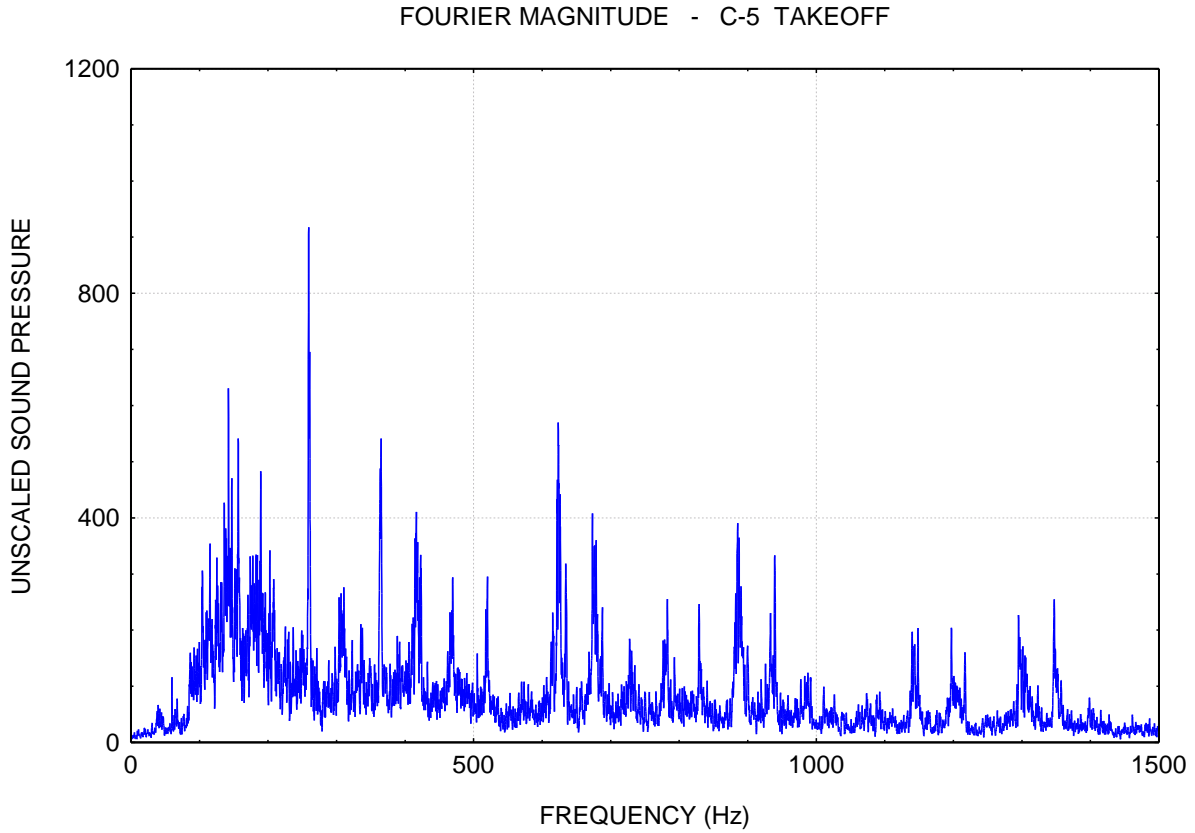
C-5 Galaxy with TF-39 Engines

The Fourier transform from the sound file is shown in Figure 5. The frequency spacing is

51 Hz, which corresponds to a fan shaft speed of 3120 rpm.

The blade tip velocity is about Mach 1.1. The true Mach number is higher due to the airflow speed.

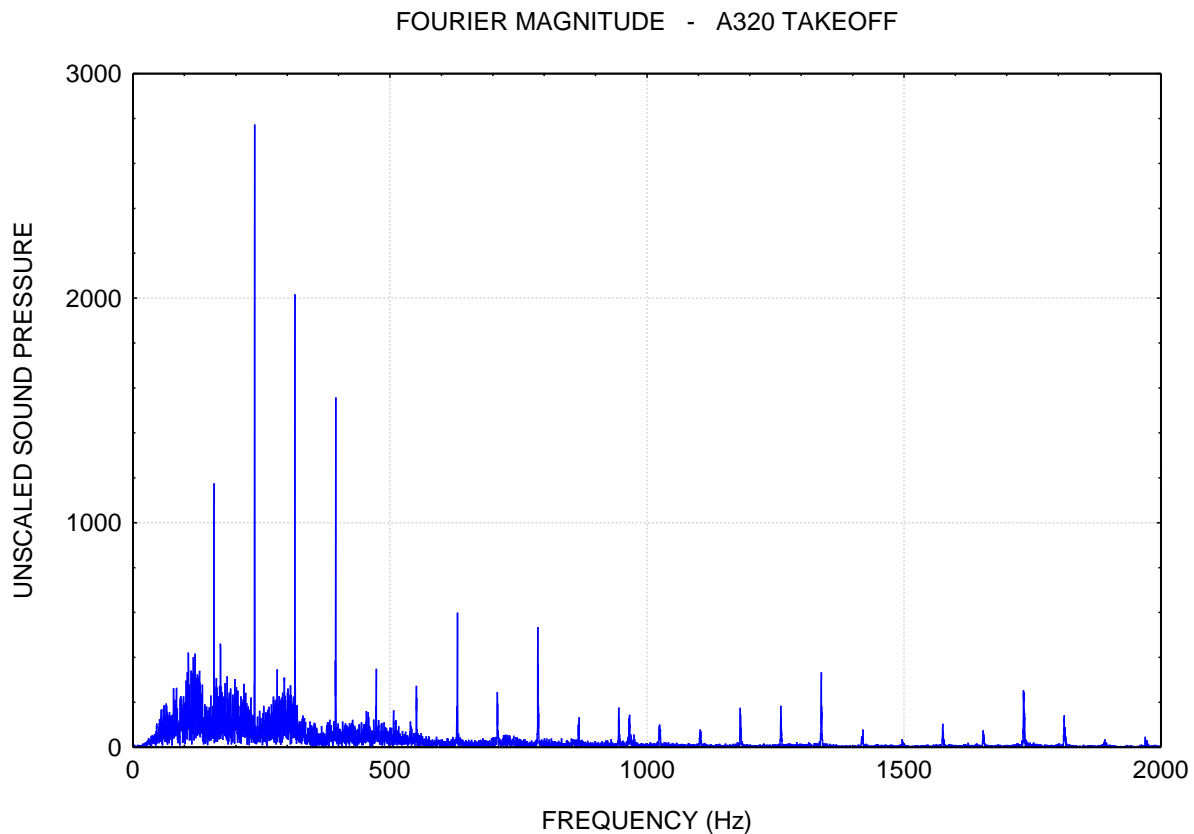
A320-232 with IAE V2527-A5 Engines

The Fourier transform from the sound file is shown in Figure 6. The spectral peaks occur at increments of 79 Hz.
