August 2011 Newsletter

## Republic XF-84H Aircraft Sound & Vibration

## Aircraft Landing Shock by Tom Irvine

## Turbofan Engine Buzz-Saw Noise by Tom Irvine

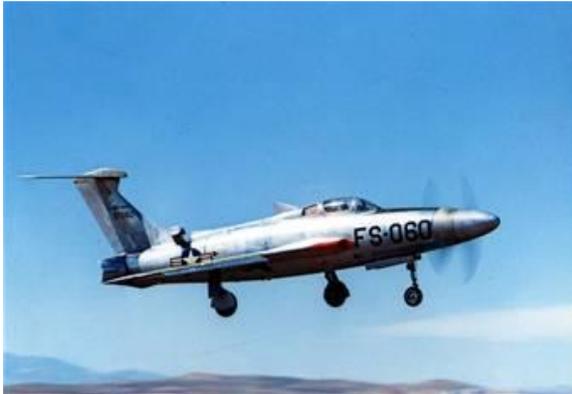
Figure 1. XF-84H Prototype

The XF-84H was built from a modified F84F airframe with a 5,850 hp Allison XT40-A-1 turboprop engine. The T40 was a pair of 2,750-shaft-horsepower T38 engines inside a common case.

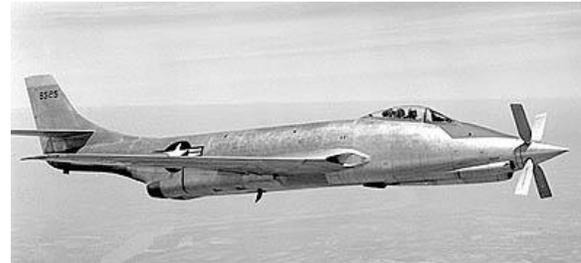
Figure 2. XF-88B

The XF-88B was powered by a nose-mounted Allison T38 turboprop engine and two turbojets. Typical takeoffs and landings were made with the propeller blades feathered and clocked in the X position. Propeller ground noise was thus not an issue.

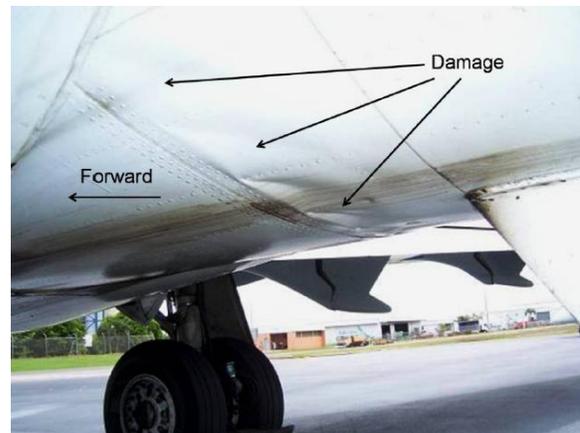
Figure 2. Fuselage Skin Panel Damage

The damage occurred in a Boeing 717-200 due to hard landing, Reference 4.

Ref.	Aircraft	Sink Rate (ft/sec)	Accel (G)	Damage
4	Boeing 717-200	17.9	3.6	Rear fuselage skin panels deformed and wrinkled.
5	Airbus A340-600	18.3	3.0	Serious damage to undercarriage
6	Boeing 747-436	17.8	2.86	Structural damage to the fuselage keel beam in the area of the landing gears, and slight <i>out-of-round</i> damage to some of the wheel hubs. <i>Quilting</i> and <i>rippling</i> of the skin panels just aft of the wing.
7	Boeing MD11	18 to 20	2.6	Right landing gear collapsed. Right wing separated.
8	Airbus A340-311	16.7	2.17	Damage to tires and landing gear hardware. No structural damage.
9	Airbus A321-2009	9.1	1.91	Tail-strike & other structural damage
10	Boeing 737-210C	6.7	1.86	Substantial damage. Left nose tire burst.

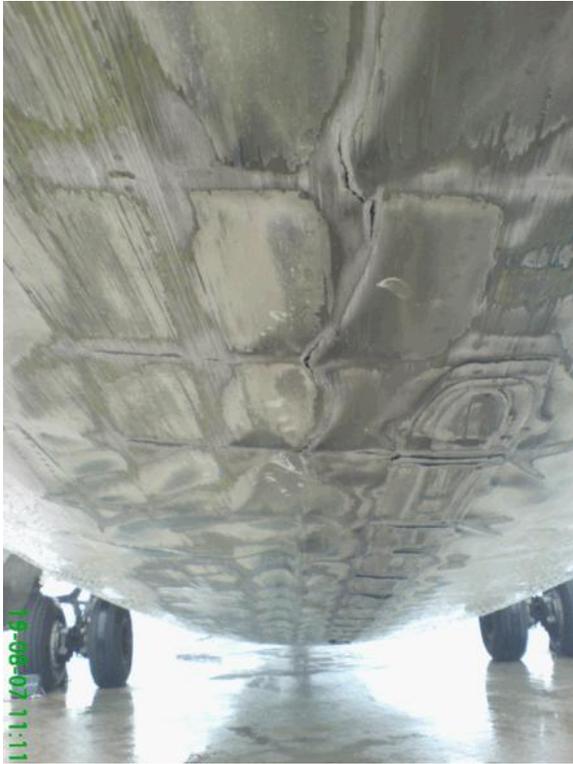
Figure 3. Tail-strike Damage

Swiss-operated BAE Systems Avro RJ100 at London City Airport, August 18, 2007.

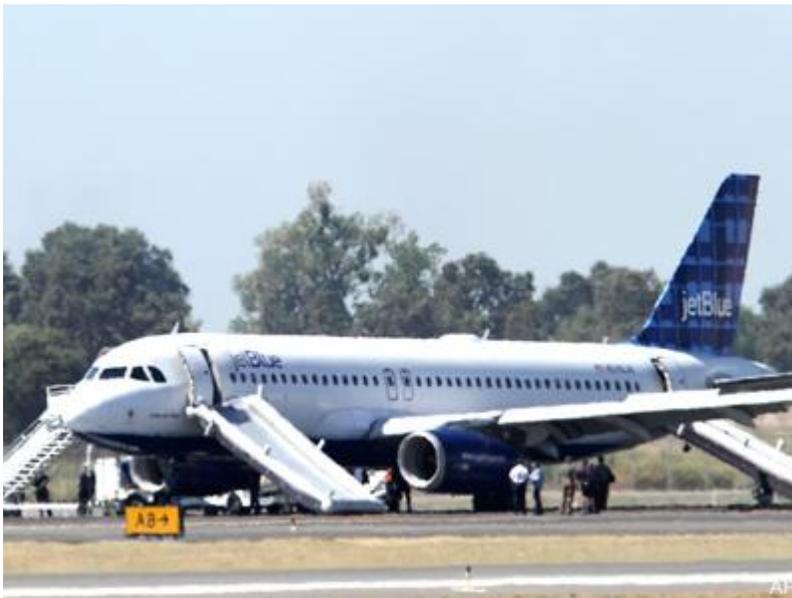
Figure 4. JetBlue Airbus A320, Hard Landing, Sacramento, August 26, 2010

The hard landing occurred because the parking brake was engaged, either through pilot error or a technical fault. Four main landing gear tires blew out, and a minor tire-related fire erupted. The passengers exited via emergency slides after the aircraft came to a standstill. Seven people had minor injuries from either the landing shock or the rapid evacuation, per NTSB report WPR10IA430.
