Welcome to Vibrationdata.com

January 2002 Newsletter

Seismic Response of the Olive View Hospital page 7

The Citicorp Building Tuned Mass Damper

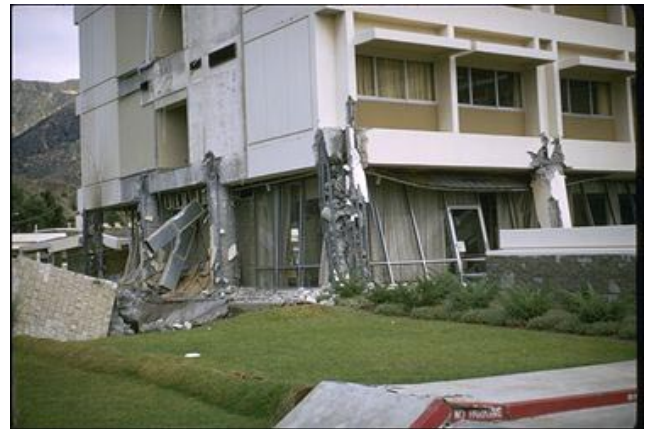
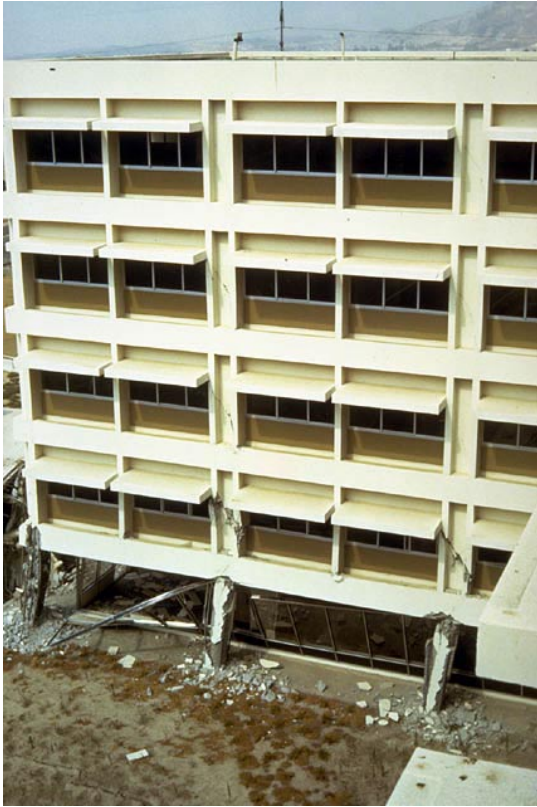
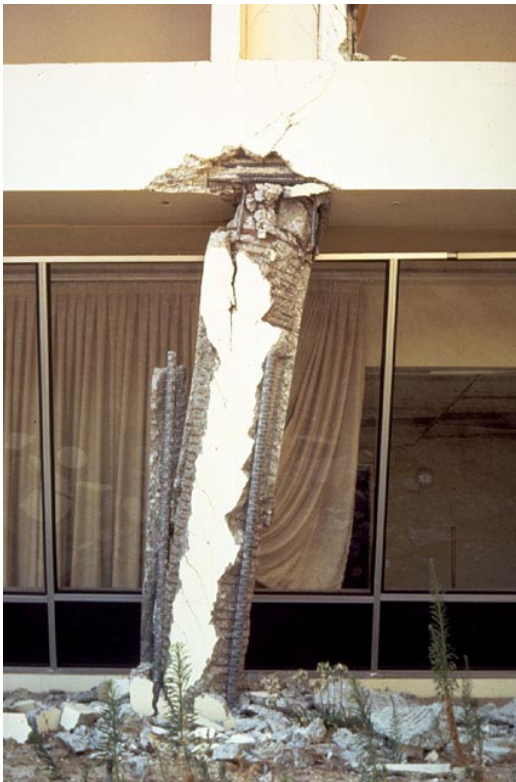
This discontinuous design thus has a "soft first story." As a result the first story columns failed, as shown in Figures 2-1 through 2-3.

The Olive View Hospital building had vertical shear walls in its upper stories to carry the inertial loads. The first floor, however, did not have shear walls. Instead, the load was carried by the first story columns down to the foundation.

One of the first story columns underwent 0.81 meters of lateral displacement in a clear height of 4.27 meters, resulting in an interstory drift index of 0.19.

Poor workmanship also contributed to the building's failure. The first story columns were spirally reinforced, but the spiral ended prematurely at the top of each column. Thus the spiral did not connect to spandrel girder. As a result, a "plastic joint" was created that was unable to provide the needed lateral confinement.

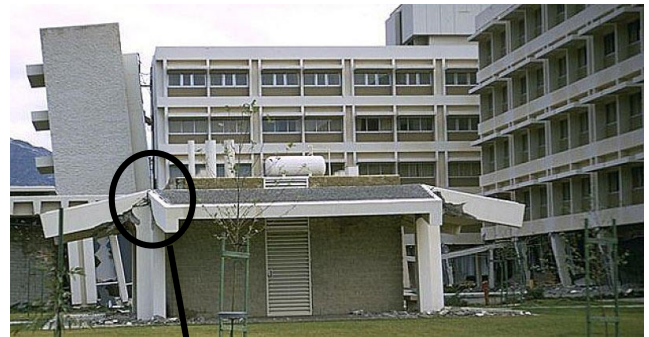
A cantilever beam protruding from a roof is shown in Figure 2-4. The beam underwent such a high bending stress that it fractured as shown in Figure 2-5.

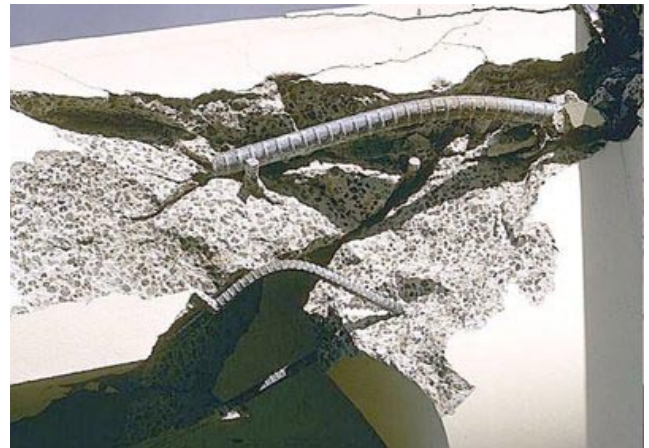
Figure 2-5.

The bending stress causes both axial tension and compression. The top bar in Figure 2-5 was subject to high tension. The lower bar buckled in compression.

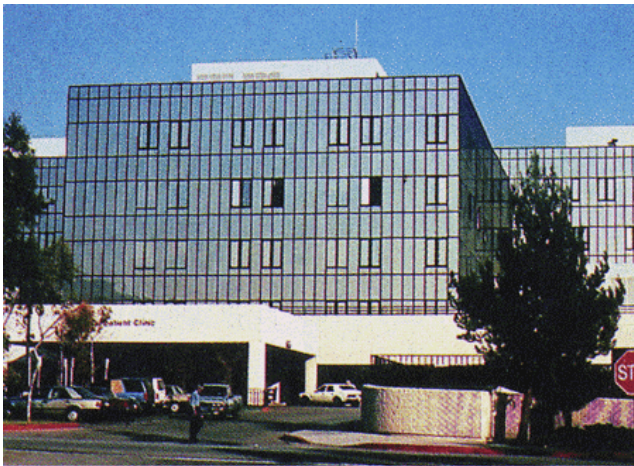
Figure 2-6.

The new Olive View building, shown in Figure 2-6, was designed to withstand increased levels of ground motion, based on the lessons of its predecessor. It is very strong and stiff. The foundation consists of spread footings and concrete slab-on-grade for the first floor. The first and second stories are built of concrete shear walls 25 centimeters thick. Steel shear walls are used for remaining upper stories.
