HELICOPTER GROUND RESONANCE Revision B

By Tom Irvine

February 23, 2005

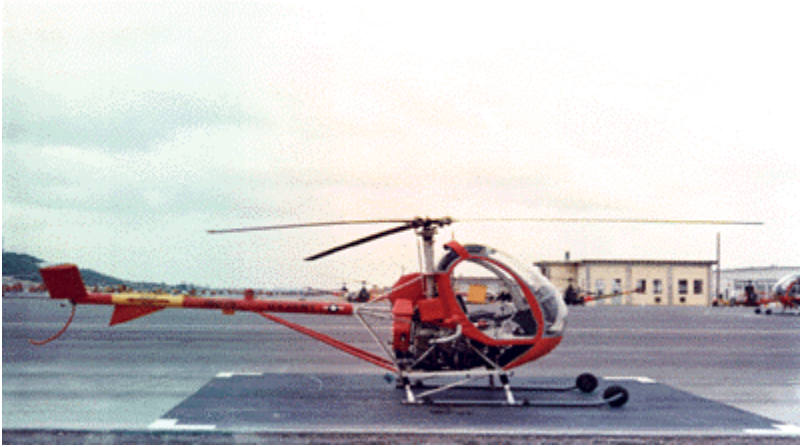
Figure 3. TH-55 Osage, Military Version of the Hughes 269A.

An intact TH-55 helicopter is shown in Figure 3.

A Hughes 269A helicopter, similar to the one in Figure 3, encountered a ground resonance problems as described in the following summary.

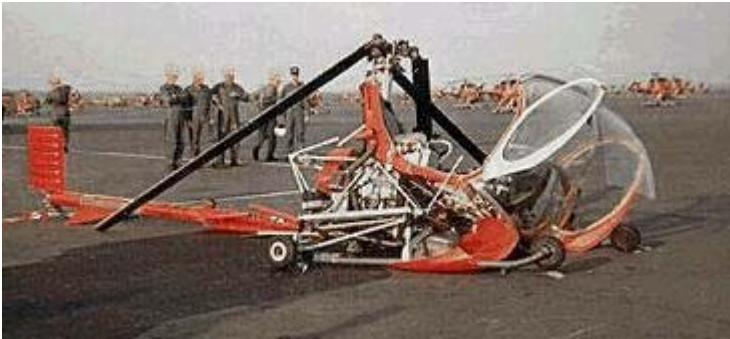
Figure 4. A TH-55 Destroyed by Ground Resonance

A similar TH-55 helicopter was destroyed by ground resonance in March 1967, at Ft. Wolters, TX, as shown in Figure 4.

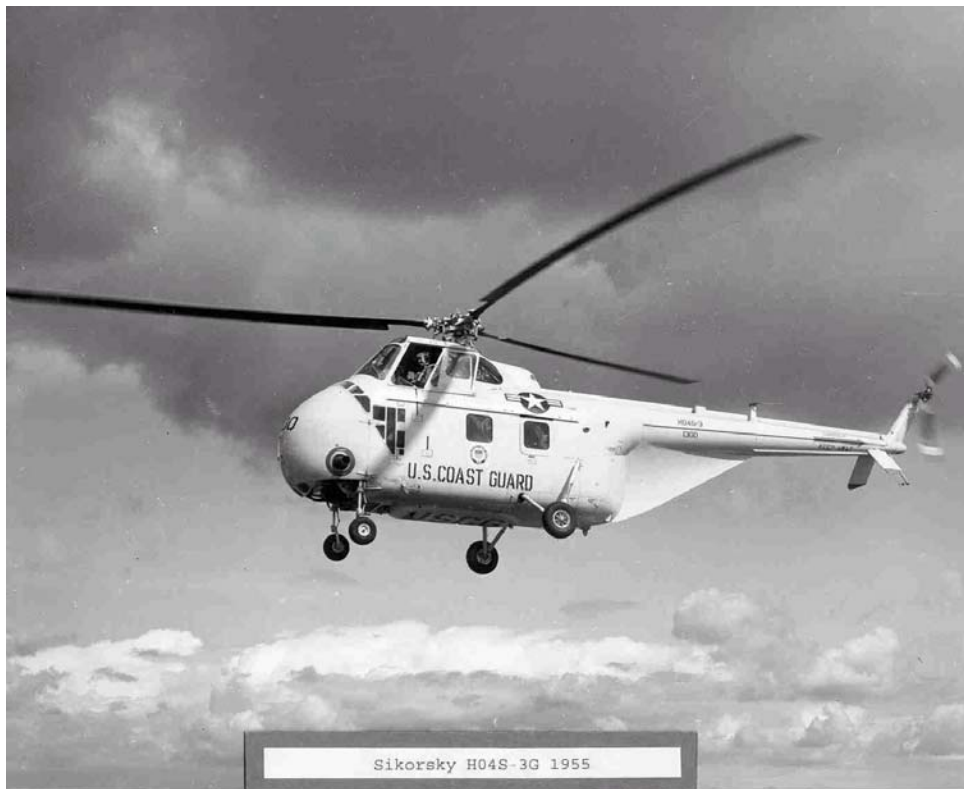
Figure 5. Sikorsky H04S

Commander James Edgar Waldron, U. S. Naval Reserve (Ret.), encountered ground resonance while flying an HO4S helicopter in the Antarctic. He wrote the following story in “Flight of the Puckered Penguins.”

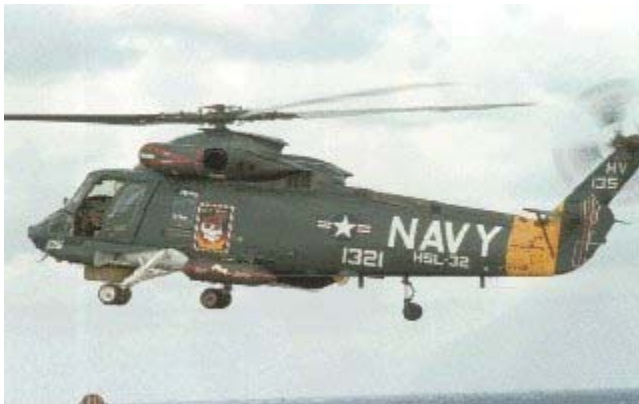
Figure 6. Typical Seasprite
