# **VIBRATIONS INDUCED BY CONSTRUCTION TRAFFIC: A HISTORIC CASE STUDY**

Justin T. Henwood and Khamis Y. Haramy

Federal Highway Administration, Denver, CO 80225

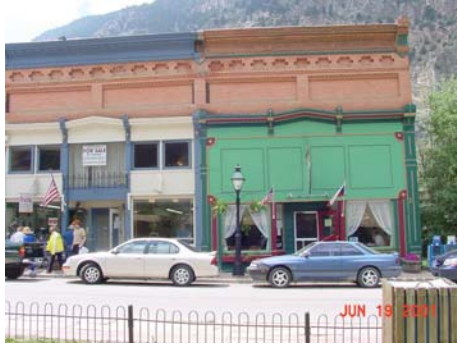
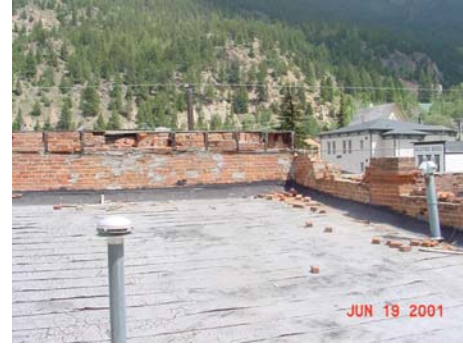
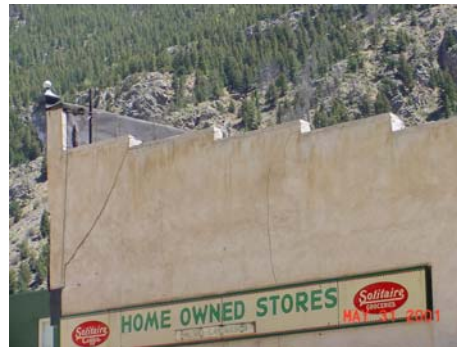
*Figure 3. Condition of monitored structures.*

It became necessary during the test program to haul construction materials through Georgetown, using 10-wheel end dumps with a loaded weight of approximately 25 tons. Due to tight corners and buildings in close proximity to the road, only one haul route was made possible, which traveled by several historic structures. Compliant with the City of Georgetown, the FHWA and Olson Engineering conducted a vibration and noise study during the hauling operation to monitor potential effects on these historic structures. Many of the monitored structures were originally erected during the mid to late 19<sup>th</sup> century and were constructed of a "soft brick" milled in town during the silver mining era.

Initially, 12 Mini-Seis II units were installed at vibration sensitive locations along the haul route. The 12 locations were selected based on a field survey and input from local residents. Most of the seismographs were placed on the ground, within 3.0 m and 6.1 m of the roadway shoulder. One seismograph was placed on the roof of one building to monitor any vibration amplification through the structure. An exterior structural assessment of each monitored location was also conducted. Notes and photographs of each structure were taken to document any existing damage.
